**TO:** Mayor and City Council  
**THROUGH:** Tim Murray, City Administrator  
**FROM:** Deanna Kuennen, Community & Economic Development Director  
**MEETING DATE:** November 2, 2021  
**SUBJECT:** Farmer Seed Building - Potential Redevelopment Discussion

# Farmer Seed and Nursery Company

*Structural Evaluation Report*

*2/4/2020*

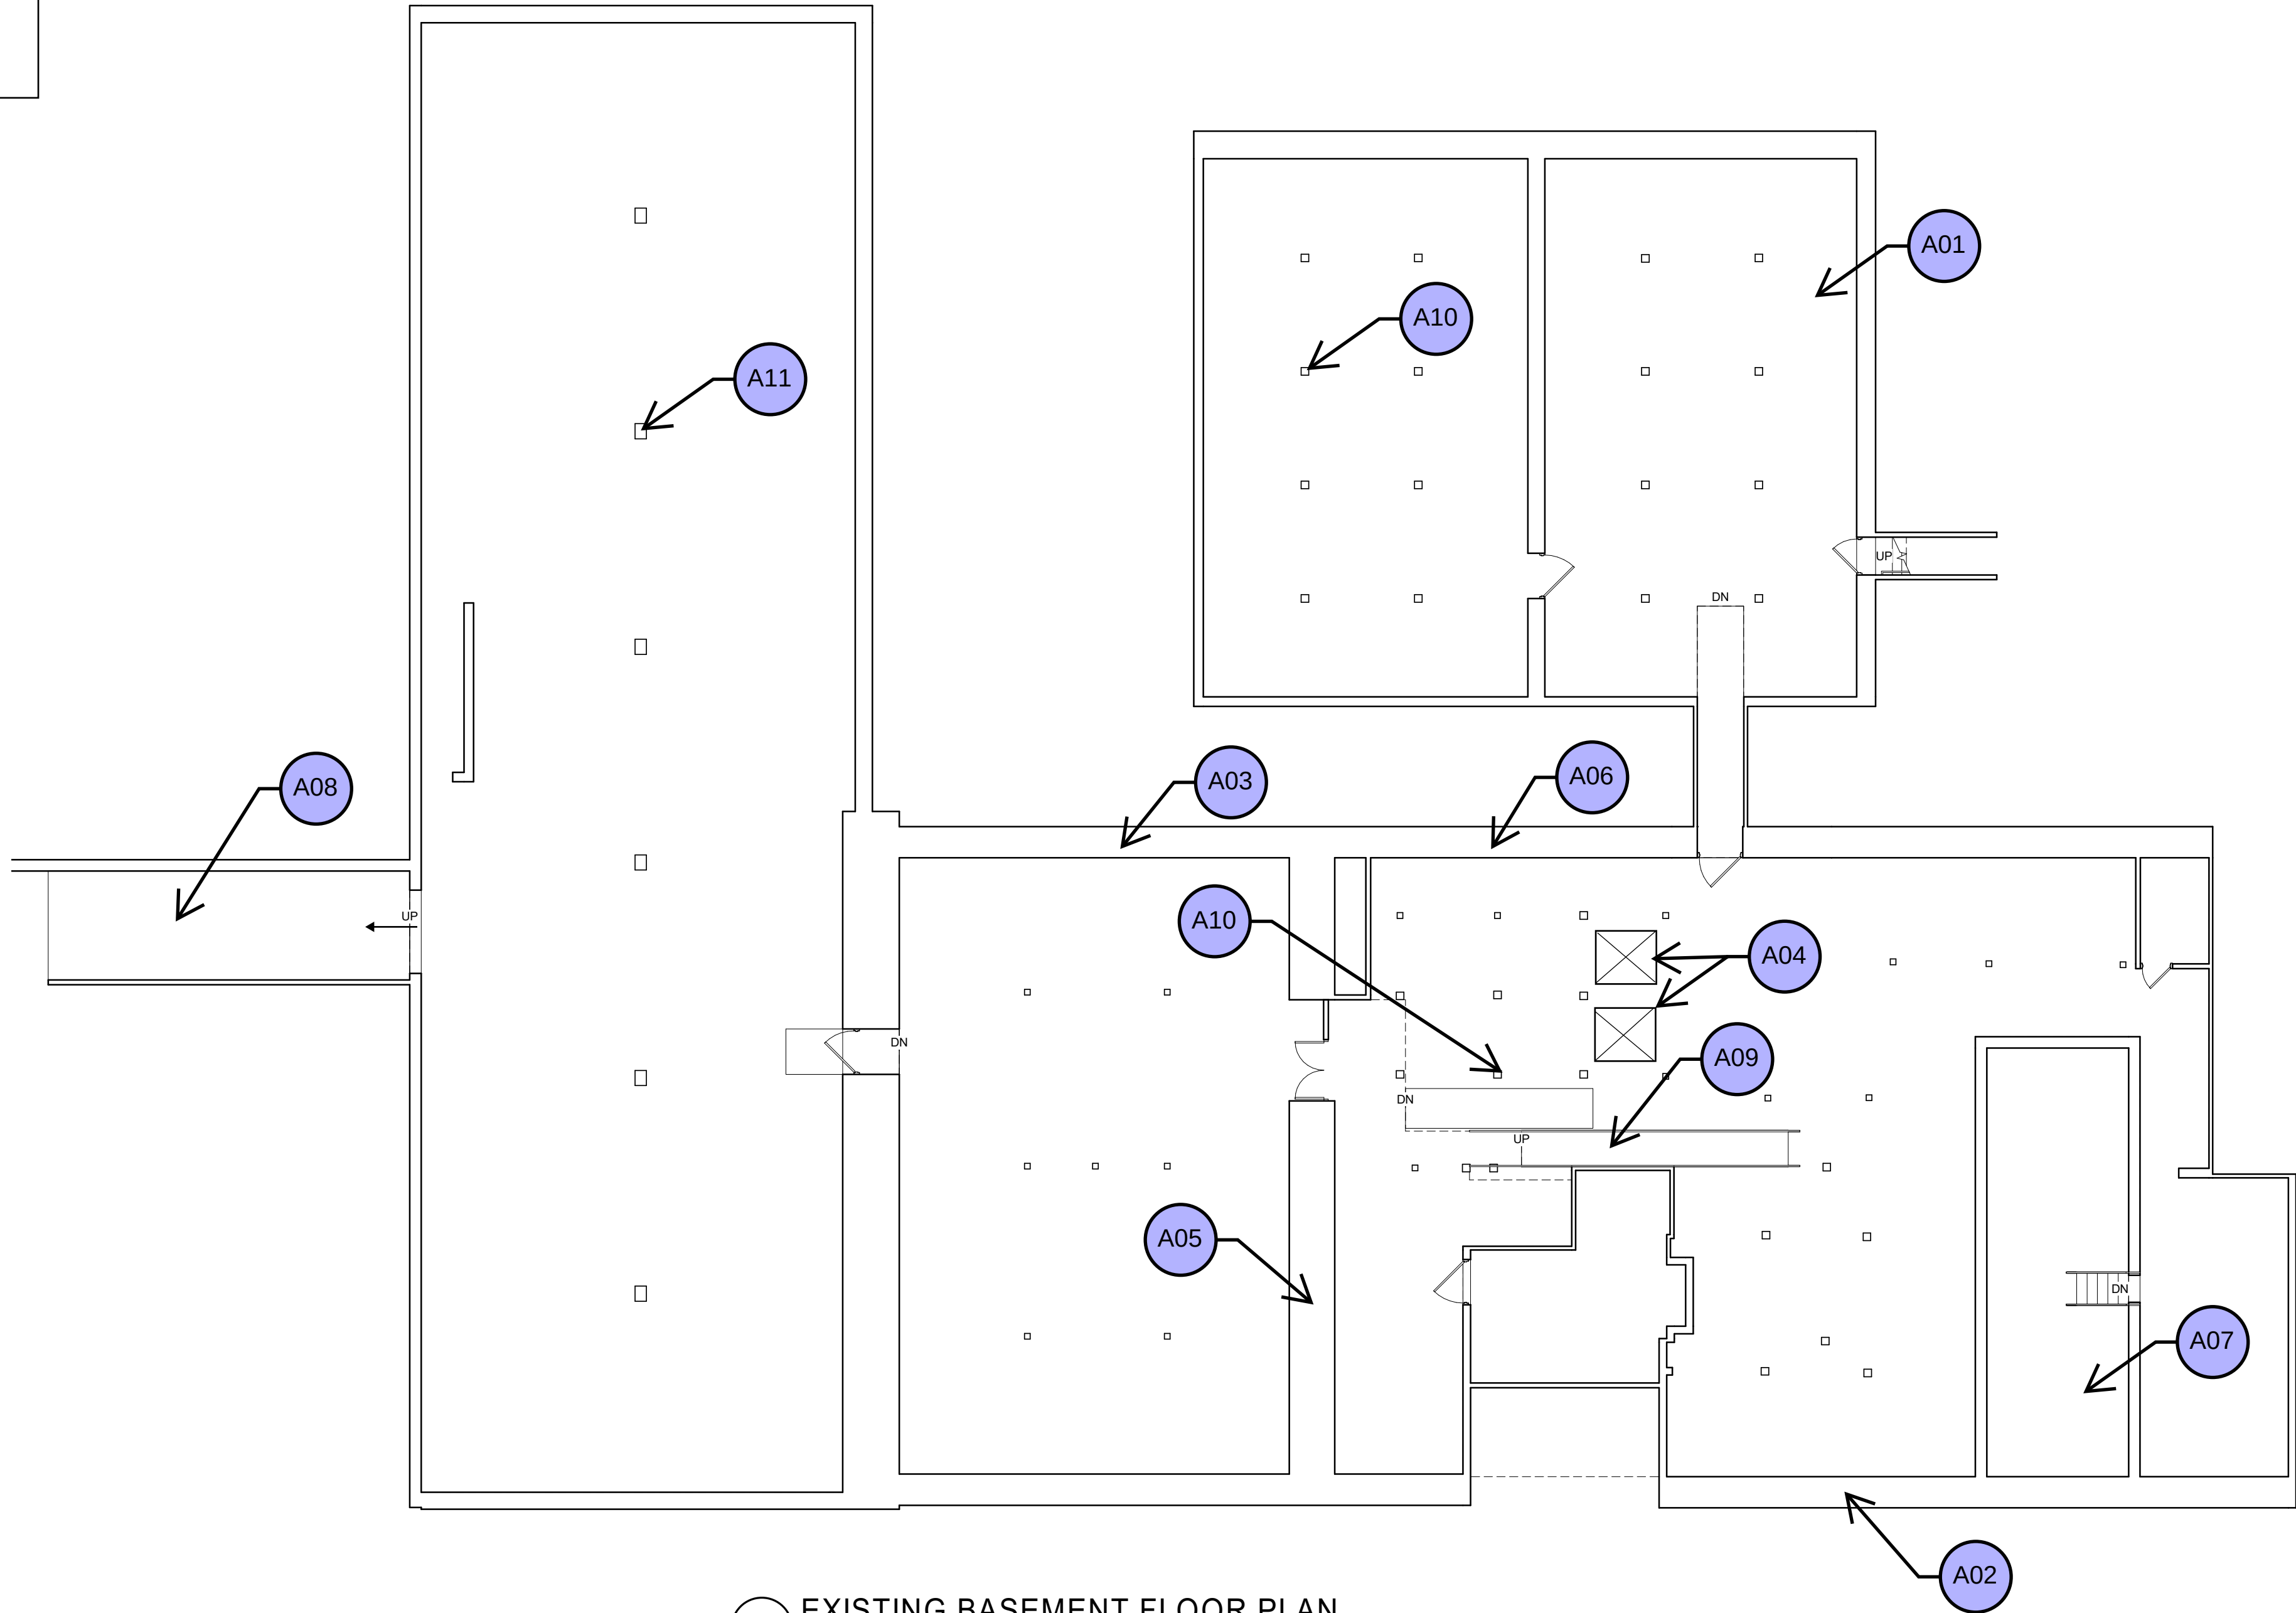
1 EXISTING BASEMENT FLOOR PLAN  
3/32" = 1'-0"

A01 - OLD COLD STORAGE FACILITIES. NO STRUCTURAL ISSUES VISIBLE. MOISTURE PRESENT ON CEILING.  
A02 - CAST-IN-PLACE CONCRETE FOUNDATION WALLS IN FINE CONDITION.  
A03 - MASONRY FOUNDATION WALLS IN FINE CONDITION.  
A04 - HOPPERS EXTENDING DOWN INTO BASEMENT SPACE FROM FLOOR ABOVE.  
A05 - STONE FOUNDATION WALL IN FINE CONDITION.  
A06 - BRICK FOUNDATION WALL IN FINE CONDITION.  
A07 - ROOM HOUSING NUMEROUS PIECES OF MECHANICAL EQUIPMENT.  
A08 - CONCRETE RAMP UP TO PRE-ENGINEERED METAL BUILDING ON FIRST FLOOR.  
A09 - WOOD RAMP FROM FIRST FLOOR DOWN INTO BASEMENT LEVEL. NUMEROUS CHANGES IN FLOOR ELEVATION EXIST THROUGH THIS MAIN LEVEL OF THE BASEMENT.  
A10 - HEAVY TIMBER COLUMNS TYPICAL THROUGHOUT THIS SECTION OF THE BASEMENT.  
A11 - CONCRETE COLUMNS IN THIS AREA OF THE BASEMENT.

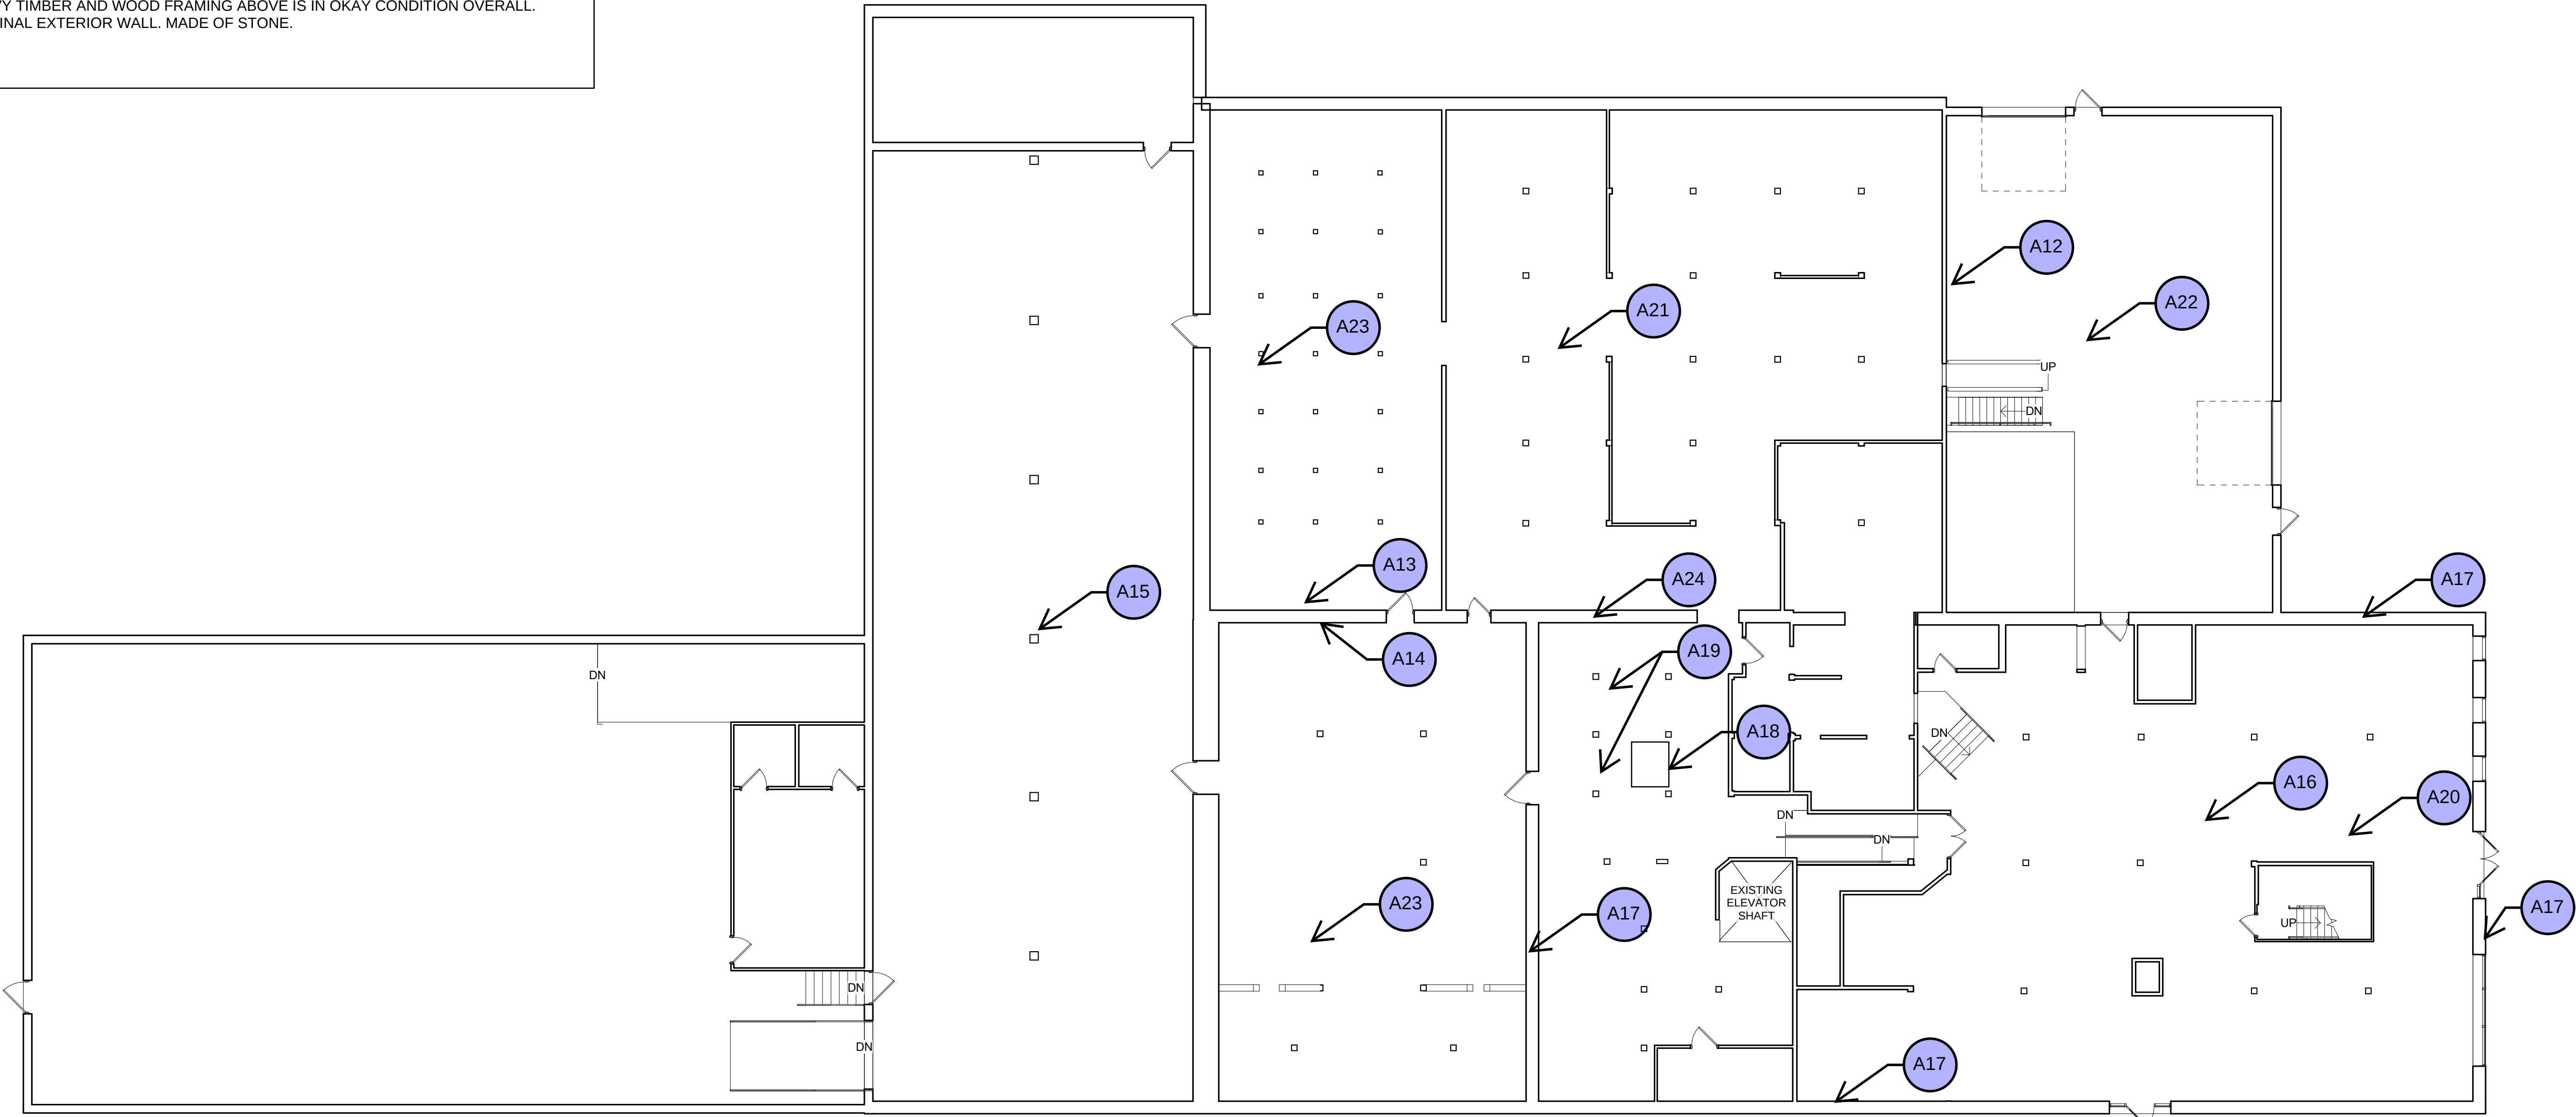
1 EXISTING FIRST FLOOR PLAN  
3/32" = 1'-0"

A12 - OLD WOOD LOADING DOCK APPEARS TO HAVE BEEN PRESENT HERE IN PAST; JOIST POCKETS STILL VISIBLE IN STONE WALL THAT WAS AT ONE TIME AN EXTERIOR WALL.  
A13 - MOISTURE ON FLOOR; EVIDENCE THAT WATER FROM ROOF LEAKS ABOVE THIS AREA ON THIRD AND FOURTH FLOORS IS MAKING ITS WAY TO LOWER LEVELS.  
A14 - MOISTURE PRESENT ON ABOUT 100 SQUARE FEET OF WALL. PLASTER COVERING WALL IS WET AND DETERIORATING, BUT NO STRUCTURAL ISSUE; BUT IT IS EVIDENCE THAT MOISTURE IS MAKING ITS WAY DOWN THIS WALL FROM LEAKS IN ROOF ABOVE.  
A15 - CONCRETE BEAM AND COLUMNS SUPPORTING PRECAST HOLLOW CORE PLANK.  
A16 - FINISHED SPACE WITH HARD CEILING. PREVIOUSLY RETAIL SPACE.  
A17 - ROCK FACE FARIBAULT STONE WALL; GROUND LEVEL TO 2ND FLOOR FRAMING.  
A18 - SCALE USED TO WEIGH SEED DISCHARGED FROM GRAIN BINS ABOVE. SCALE WOULD LIKELY REMAIN PART OF FUTURE USES AS A HISTORICAL FEATURE.  
A19 - GRAIN BIN HOPPERS/DISCHARGE CHUTES VISIBLE ABOVE FIRST FLOOR SPACE.

A20 - STEEL FRAMING ADDED IN PARTS OF 2ND FLOOR FRAMING. NO ISSUES VISIBLE.  
A21 - LIGHTS OFF IN THIS AREA; VERY LITTLE FRAMING WAS EASILY VISIBLE.  
A22 - STEEL ROOF FRAMING ABOVE IS IN GOOD CONDITION.  
A23 - HEAVY TIMBER AND WOOD FRAMING ABOVE IS IN OKAY CONDITION OVERALL.  
A24 - ORIGINAL EXTERIOR WALL. MADE OF STONE.

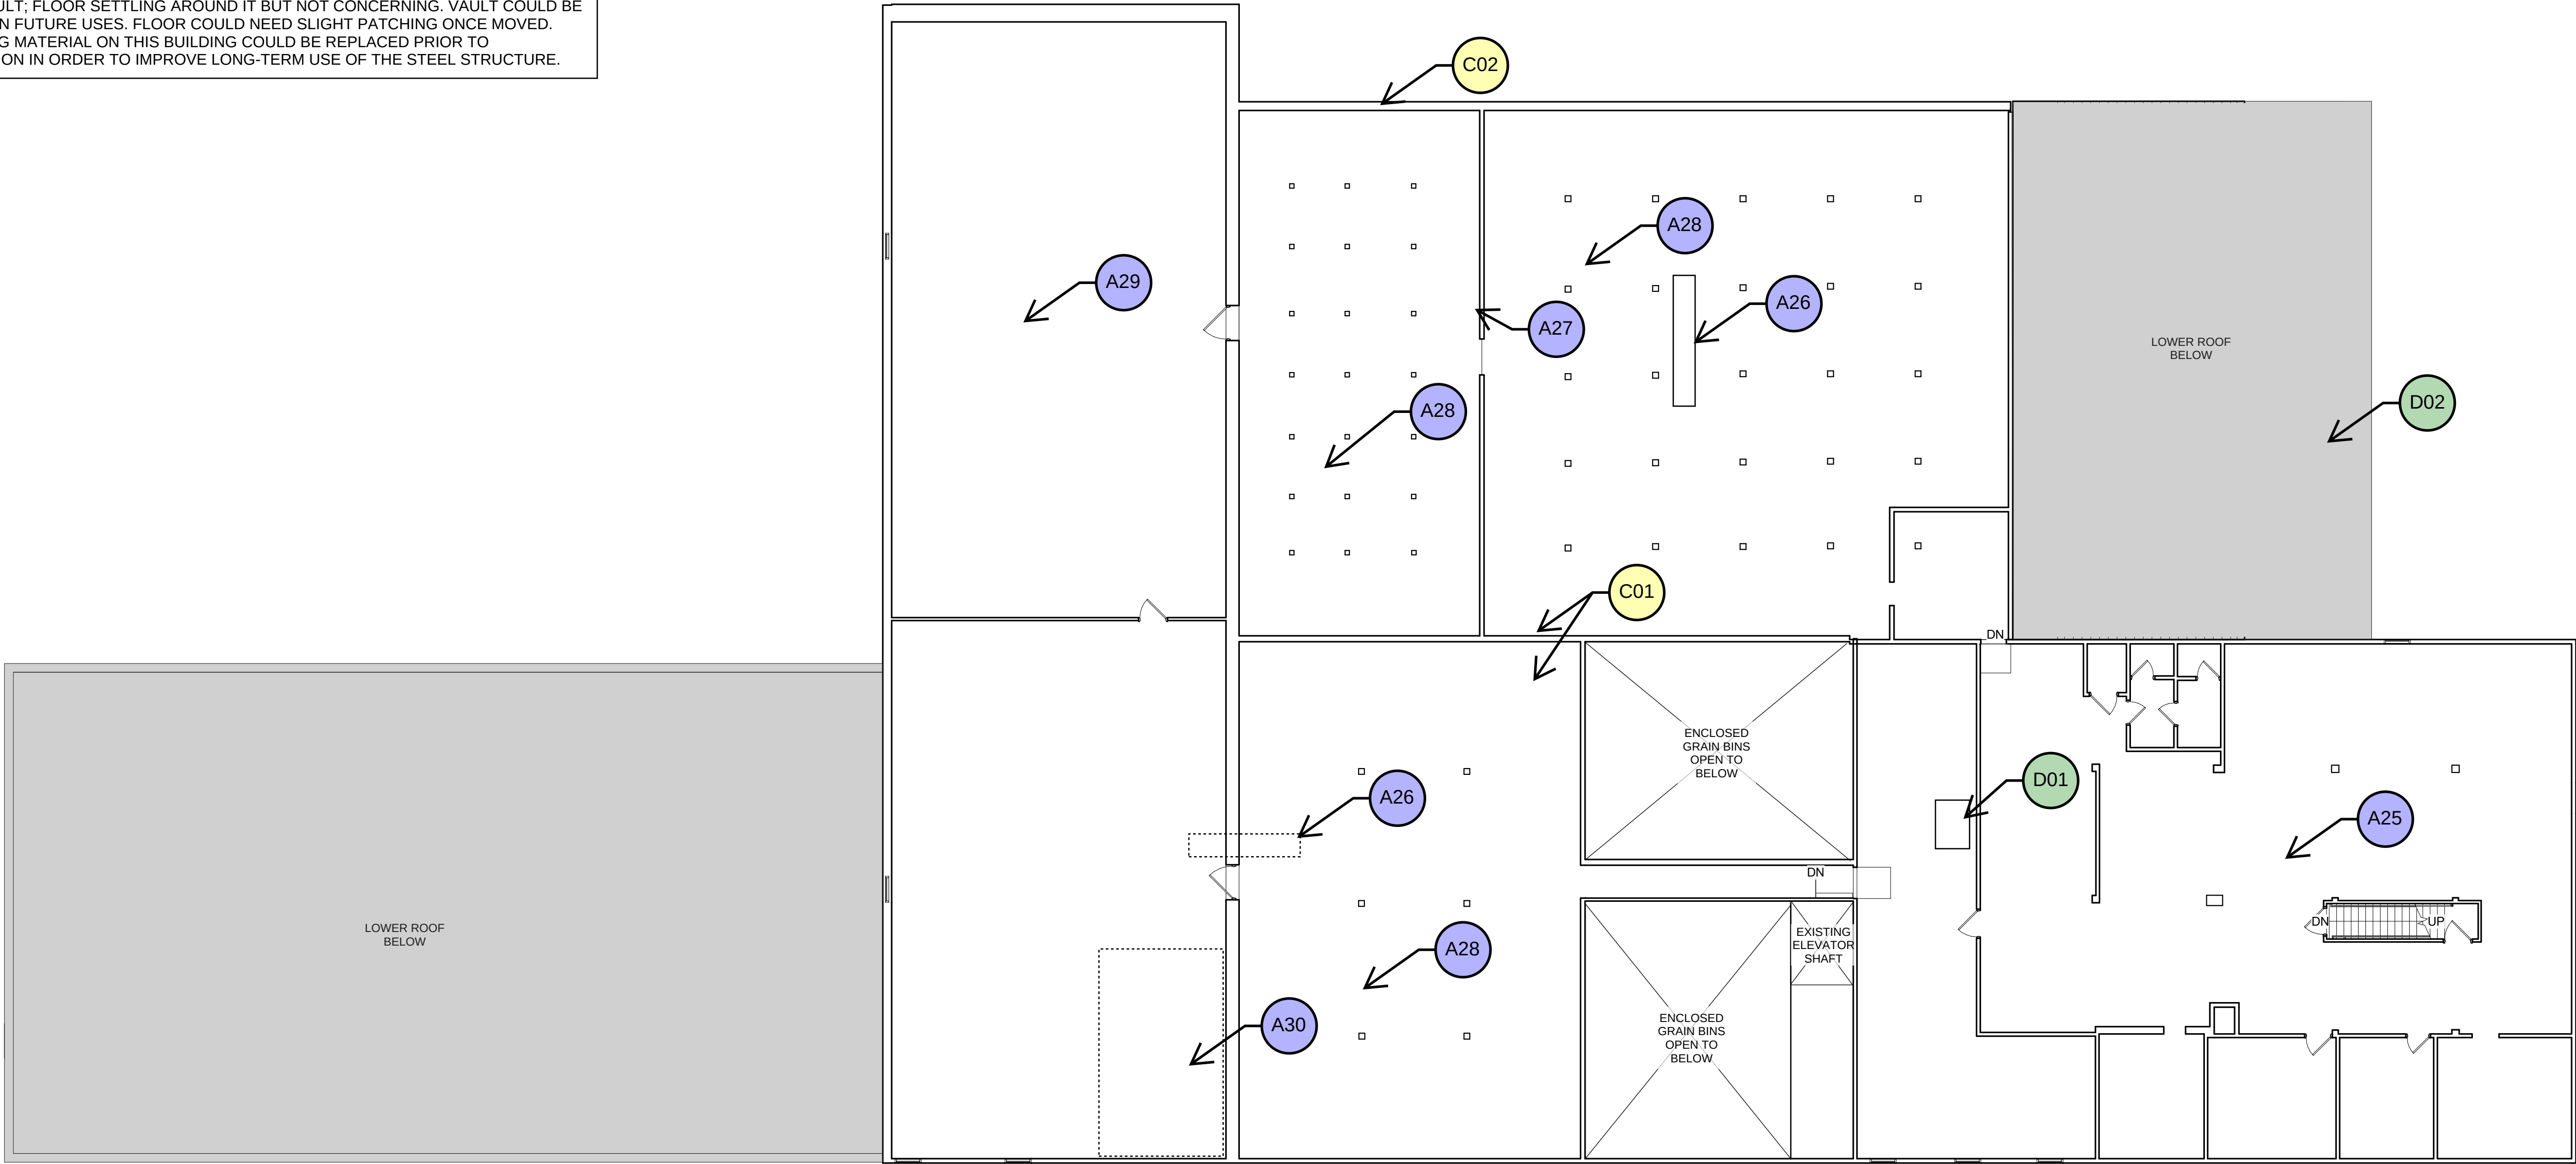
1 EXISTING SECOND FLOOR PLAN  
3/32" = 1'-0"

A25 - FINISHED SPACE WITH DROP CEILING. MOST RECENTLY USED AS OFFICE SPACE.  
A26 - CONVEYOR BELT BETWEEN FLOORS.  
A27 - OLD EXTERIOR WALL. CONSTRUCTED OF WOOD.  
A28 - WOOD FRAMING ABOVE THIS AREA IS GENERALLY IN OKAY CONDITION EXCEPT WHERE MOISTURE DAMAGE IS NOTED.  
A29 - CONCRETE FRAMING IS IN GOOD CONDITION.  
A30 - CELL TOWER EQUIPMENT. FENCE AROUND THIS AREA.

C01 - MOISTURE DAMAGE ON PART OF WOOD FLOOR NEAR HERE. FROM LEAKS ABOVE. FRAMING LIKELY NEEDS REPAIR PRIOR TO FUTURE OCCUPATION OF SPACE.  
C02 - EXTERIOR WALL HAS ONLY METAL SHEATHING ON BARE WOOD STUDS. NO SHEATHING ON INTERIOR STUD WALL; NEW SHEATHING NEEDED PRIOR TO REOCCUPATION OF SPACE. NOTE THAT OTHER ARCHITECTURAL CONSIDERATIONS MAY REQUIRE NEW INTERIOR FINISH/SHEATHING/INSULATION AROUND ENTIRE EXTERIOR.

D01 - OLD VAULT; FLOOR SETTLING AROUND IT BUT NOT CONCERNING. VAULT COULD BE RELOCATED IN FUTURE USES. FLOOR COULD NEED SLIGHT PATCHING ONCE MOVED.  
D02 - ROOFING MATERIAL ON THIS BUILDING COULD BE REPLACED PRIOR TO REOCCUPATION IN ORDER TO IMPROVE LONG-TERM USE OF THE STEEL STRUCTURE.

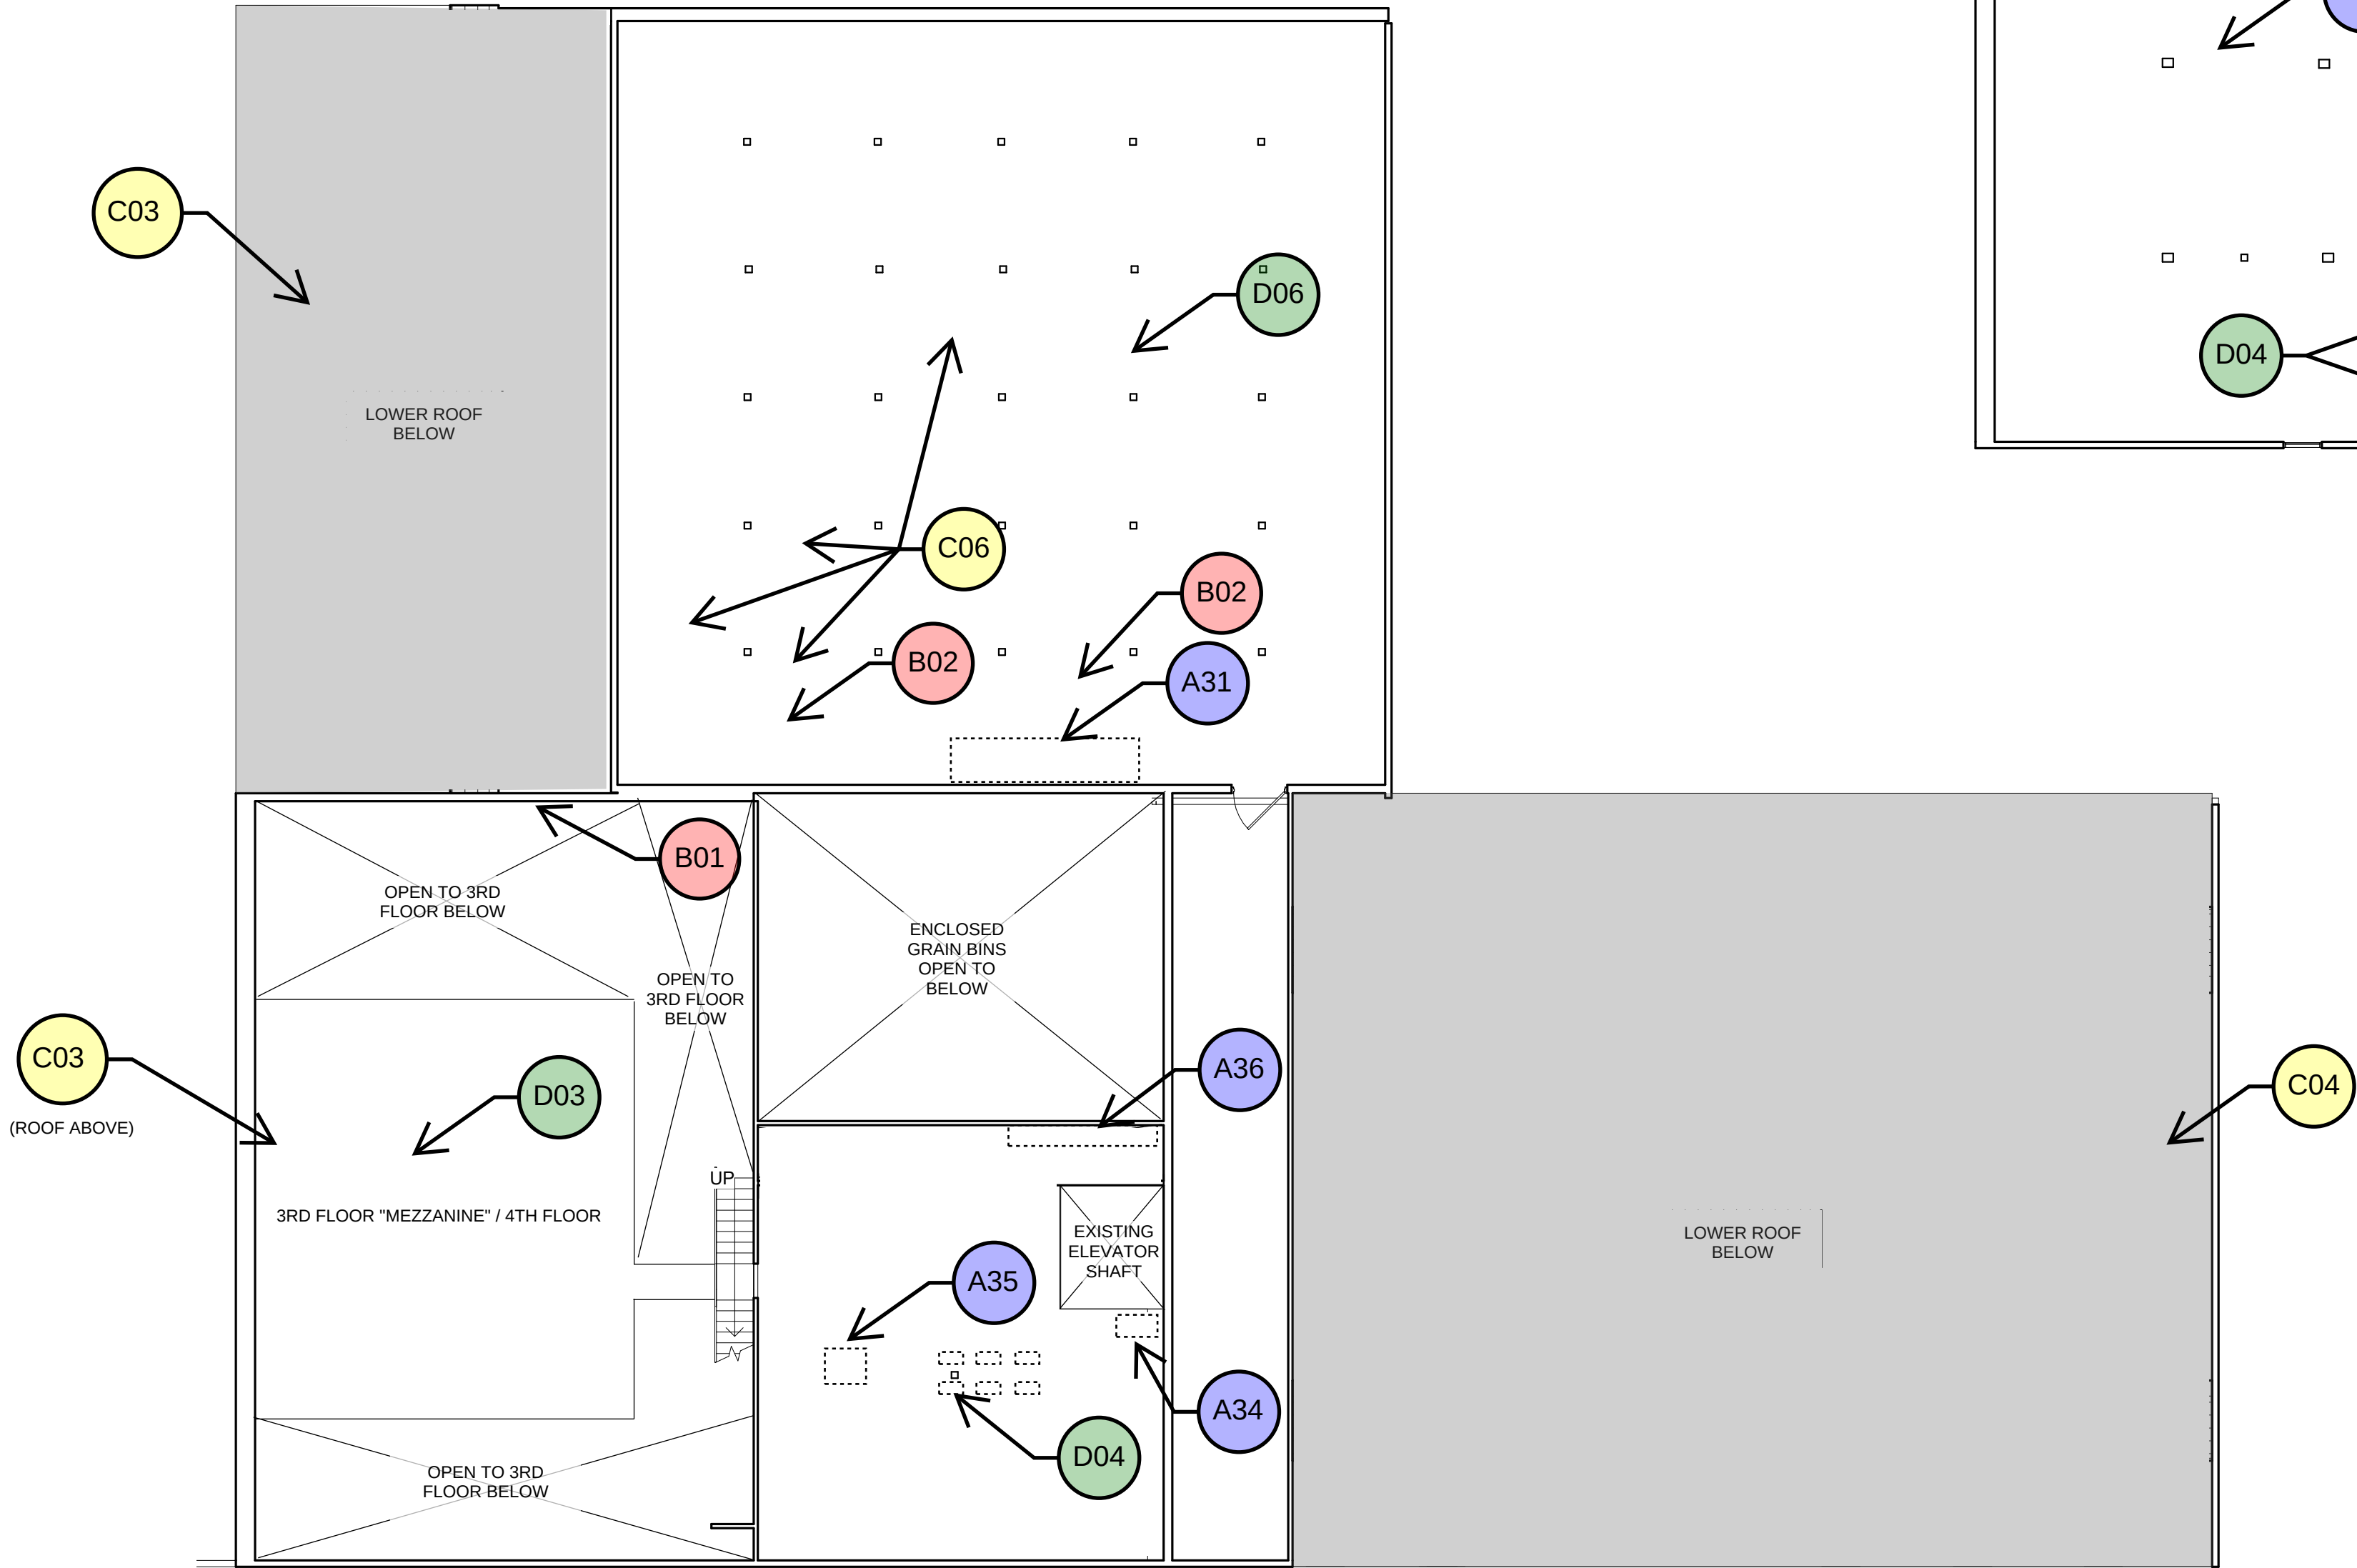
1 EXISTING THIRD FLOOR PLAN  
3/32" = 1'-0"

A31 - STAIRS BETWEEN FLOORS.  
A32 - WOOD FRAMING IS GENERALLY IN OKAY CONDITION EXCEPT WHERE NOTED.  
A33 - APPROXIMATE LOCATION OF EXISTING RESTROOMS.  
A34 - MURPHY MAN LIFT IN THIS APPROXIMATE LOCATION. GOES UP TO 7TH FLOOR.  
A35 - HATCH DOORS IN FLOOR THAT OPEN UP TO GRAIN BINS BELOW. COULD BE REUTILIZED AS A HISTORICAL FEATURE IN A FUTURE USE.  
A36 - CHUTE FROM ORIGINAL USE PROCESSING SEEDS. HISTORICAL VALUE LIKELY.

C03 - MEMBRANE ROOF. NO VISIBLE ACTIVE LEAKS IN NEED OF IMMEDIATE REPAIR, BUT ROOFING SHOULD BE REPLACED IN THE NEXT 1-3 YEARS.  
C04 - ROOF IS HALF MEMBRANE AND HALF CORRUGATED LIGHT GAGE METAL. AGE UNKNOWN AND NO VISIBLE LEAKS. BUT ROOFING SHOULD BE REPLACED SUCH THAT IT IS OF ONE MATERIAL IN THE NEXT 1-3 YEARS. SOME NEW SHEATHING VISIBLE BELOW ROOF.  
C05 - FLOOR BOARDS ARE BUCKLING DUE TO MOISTURE DAMAGE FROM LEAKS IN ROOF AND FLOOR ABOVE. JOISTS AND FLOORING IN THIS GENERAL AREA WOULD NEED REPAIRS PRIOR TO REOCCUPATION OF THE BUILDING.  
C06 - MOISTURE DAMAGE ALREADY VISIBLE IN FLOOR FRAMING BELOW. REPLACEMENT OF SOME FRAMING IS LIKELY NEEDED BEFORE REOCCUPATION OF SPACE.

D03 - WOOD-FRAMED "MEZZANINE" THAT IS AT SAME LEVEL AS REST OF FOURTH FLOOR. FRAMING IS IN FINE CONDITION, BUT REMOVAL OF THE MEZZANINE IS LIKELY NEEDED TO MAKE THE 3RD FLOOR USABLE AS A FUTURE RESIDENTIAL OR OFFICE SPACE.  
D04 - ADDITIONAL GRAIN BIN SPACE THAT COULD BE MODIFIED TO ALLOW MORE SPACE FOR FUTURE RESIDENTIAL OR COMMERCIAL USES ON THIRD FLOOR.  
D05 - WOOD "CHASES" THAT CURRENTLY HOUSE SOME CELL TOWER EQUIPMENT. CHASES MAY NEED TO REMAIN IN FUTURE LAYOUTS.  
D06 - NOT MUCH HEAD HEIGHT IN THIS AREA. FUTURE RESIDENTIAL USES COULD UTILIZE THIS SPACE AS "LOFT SPACE" THAT MAY REQUIRE SOME OF THE FOURTH FLOOR FRAMING TO BE REMOVED. THIS COULD BE STRATEGICALLY DONE TO AVOID REPLACING SOME OF THE ALREADY MOISTURE-DAMAGE FLOOR FRAMING OF FOURTH FLOOR.

ESTIMATED AT \$5,000 TO \$10,000 FOR CONSTRUCTION COSTS ASSOCIATED WITH "URGENT" REPAIRS OF ACTIVE ROOF LEAKS IN APPROXIMATELY (3) LOCATIONS. REFER TO KEY PLAN NOTES FOR APPROXIMATE LOCATIONS. ISG RECOMMENDS A LOCAL OCONTRACTOR BE ENGAGED TO PROVIDE ACCURATE QUOTES TO COMPLETE PATCHING OF ACTIVE ROOF LEAKS.

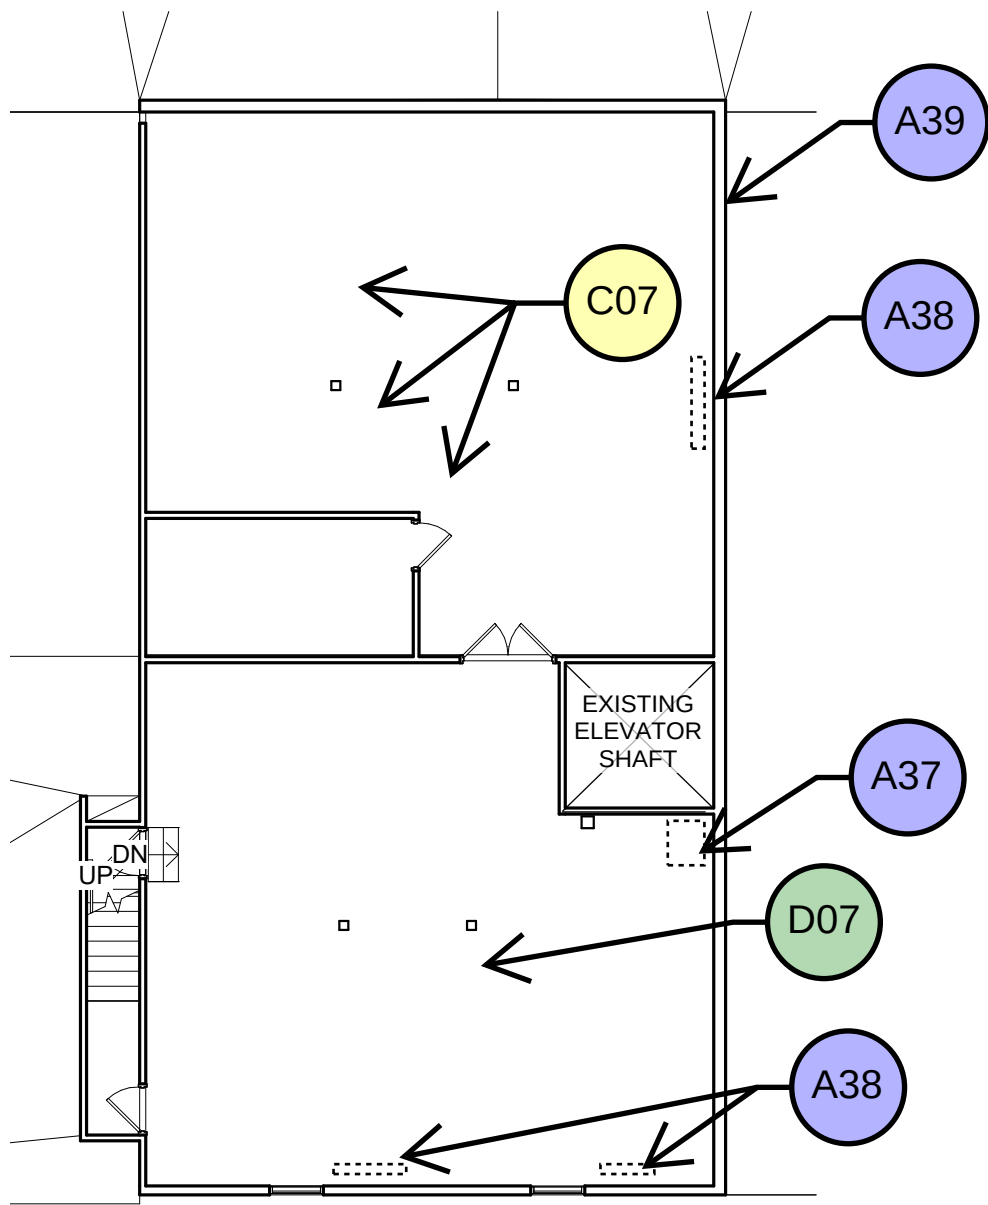
1 EXISTING FIFTH FLOOR PLAN  
3/32" = 1'-0"

C07 - ROTTING FLOOR BOARDS. SOME JOISTS AND DECKING WOULD NEED TO BE REPLACED PRIOR TO REOCCUPATION OF SPACE.  
C08 - SOME MOISTURE DAMAGED FLOOR FRAMING AND BOARDS MAY NEED REPLACEMENT PRIOR TO REOCCUPATION.  
C09 - SOME SAG IN ROOF BEAM HERE. NEEDS REPAIR OR REINFORCEMENTS PRIOR TO REOCCUPATION OF THE SPACE.

D07 - WOOD "CHASES" THAT CURRENTLY HOUSE SOME CELL TOWER EQUIPMENT. CHASES MAY NEED TO REMAIN IN FUTURE LAYOUTS.

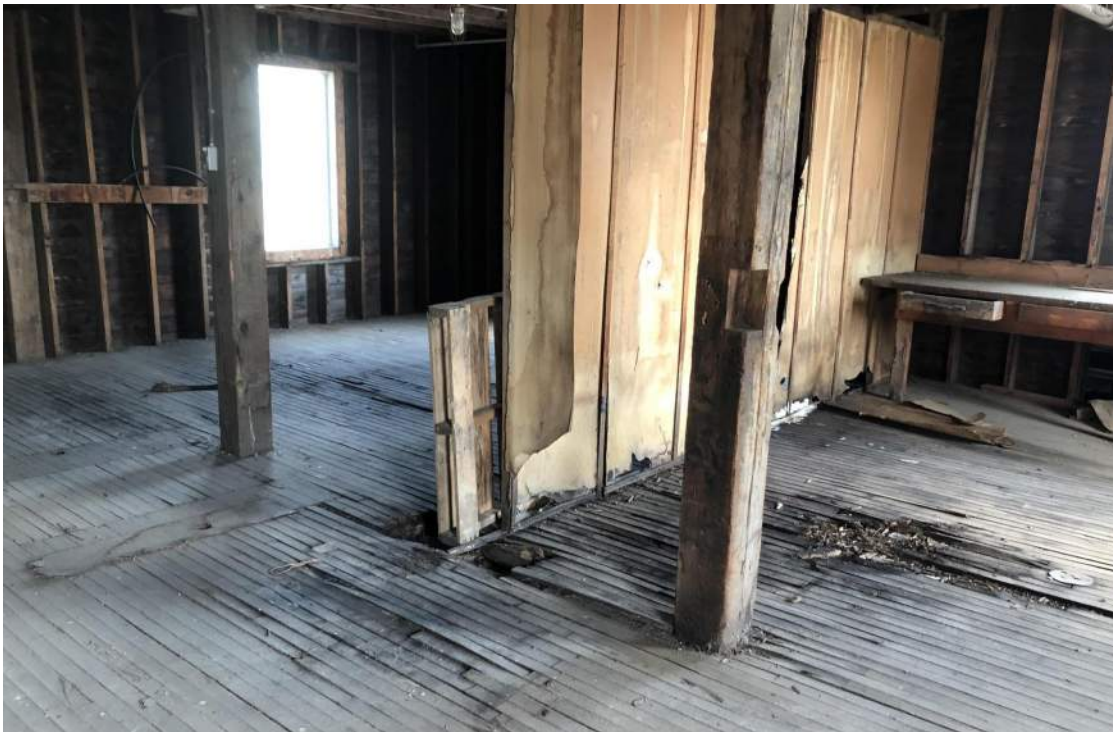
FIGURE 1 - DAMAGED FLOOR BOARDS AND JOISTS RESULTING FROM LEAKS ON ROOF ABOVE 6TH FLOOR.

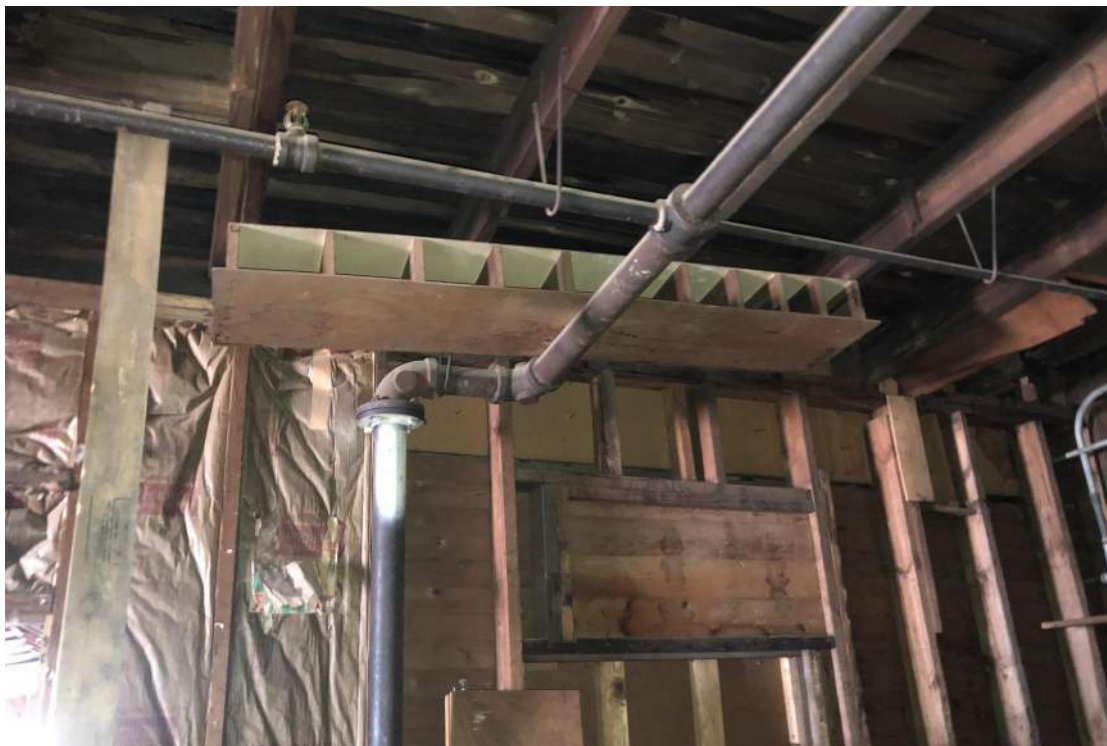
FIGURE 2 - DAMAGED ROOF FRAMING ABOVE 3RD FLOOR. PIPE IS SUPPORTING THE ROOF JOIST. ROOF IS LEAKING AT THIS LOCATION.

3. **Preservation Recommendations:** Urgent repair recommended to stop areas with active leaks. Areas where buckets are being used to collect rainwater leaks should be patched as soon as practical to preserve the building by reducing future water damage. All roofing materials above the wood framing should be replaced within 2 years. Refer to Appendix D for urgent repair cost estimates.

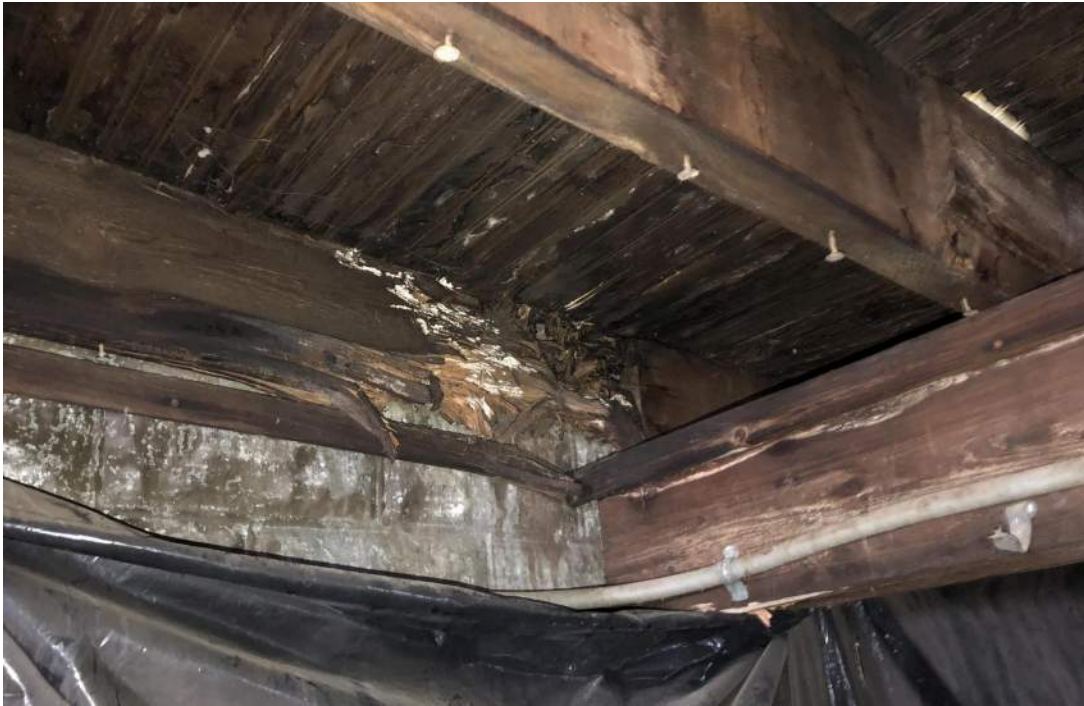
FIGURE 3 - DAMAGED FRAMING DUE TO LEAK IN ROOF ABOVE FOURTH FLOOR IN EAST WING. REPAIRS ARE NEEDED AS SOON AS PRACTICAL..

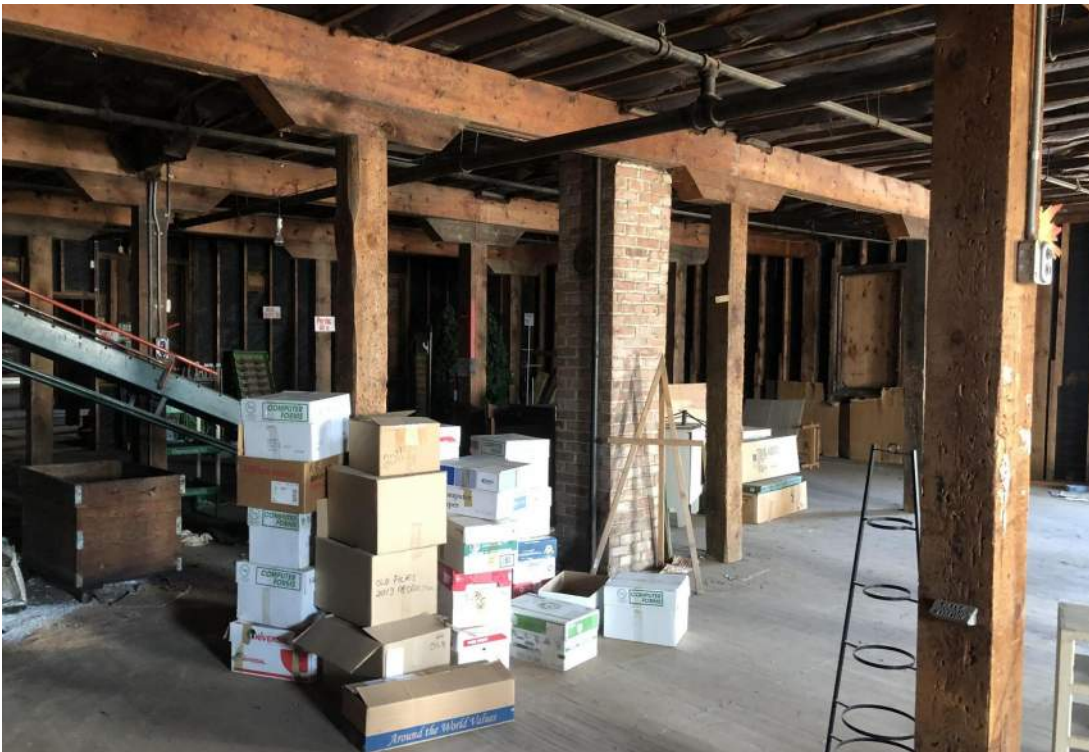
FIGURE 4 - TYPICAL WOOD FRAMING SEEN THROUGHOUT MOST OF THE BUILDING. A MAJORITY OF THE FRAMING IS IN GOOD CONDITION EXCEPT WHERE ROOF LEAKS ARE CAUSING MOISTURE INTRUSION AND DAMAGE.

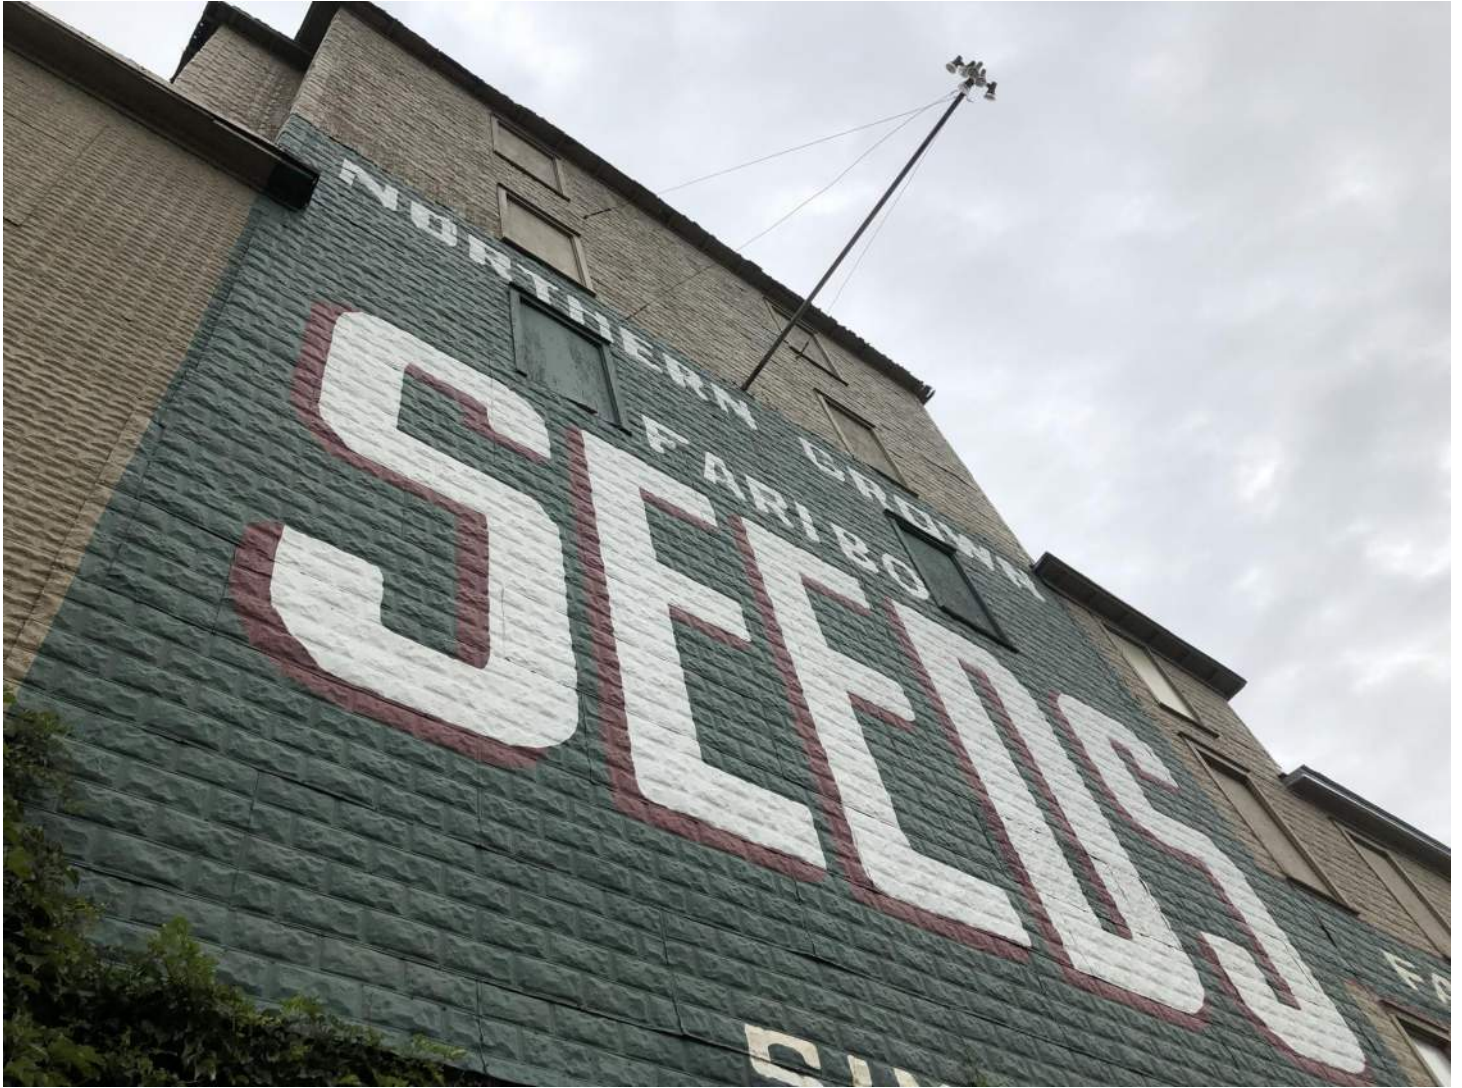
FIGURE 5 - TYPICAL METAL SIDING ON EXTERIOR WALLS. NOTE THE STONE PATTERN STAMPED ON THE METAL SHEETS.

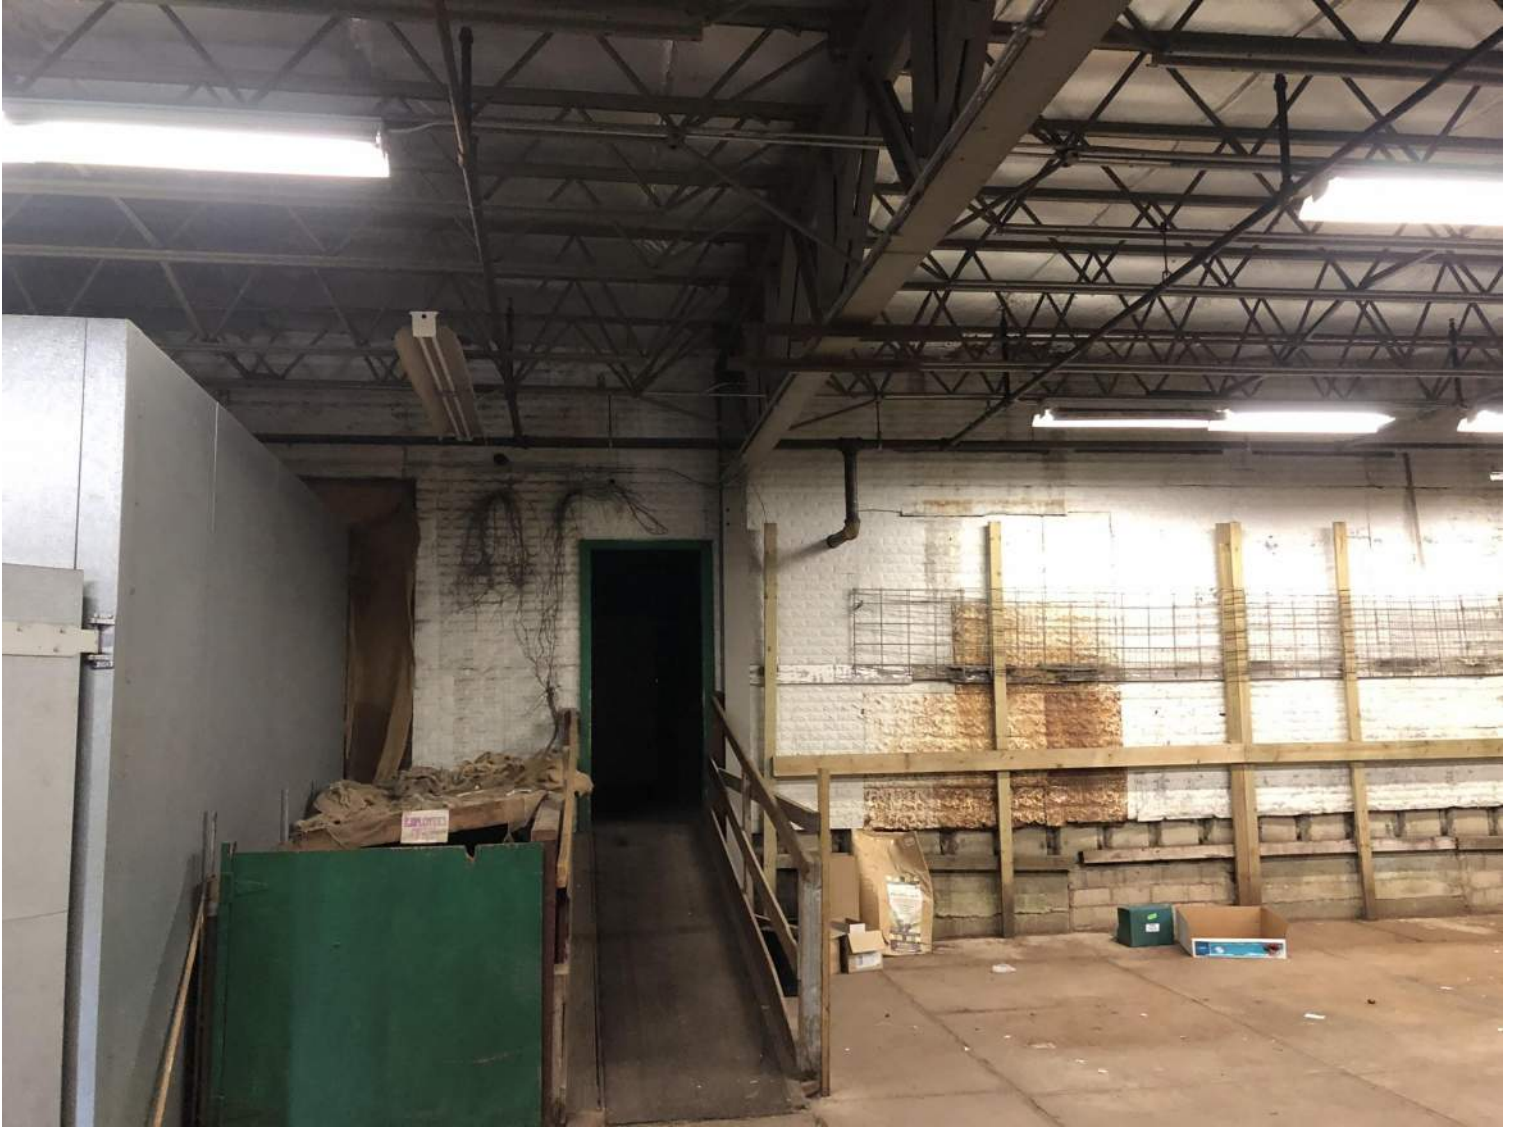
FIGURE 10 - TYPICAL STEEL FRAMING SEEN WITHIN THE STEEL-FRAMED BUILDING (CIRCA 1930).
