**TO:** Mayor and City Council  
**THROUGH:** Tim Murray, City Administrator  
**FROM:** Deanna Kuennen, Community & Economic Development Director  
**MEETING DATE:** November 2, 2021  
**SUBJECT:** Farmer Seed Building - Potential Redevelopment Discussion

# Farmer Seed and Nursery Company

*Structural Evaluation Report*

*2/4/2020*

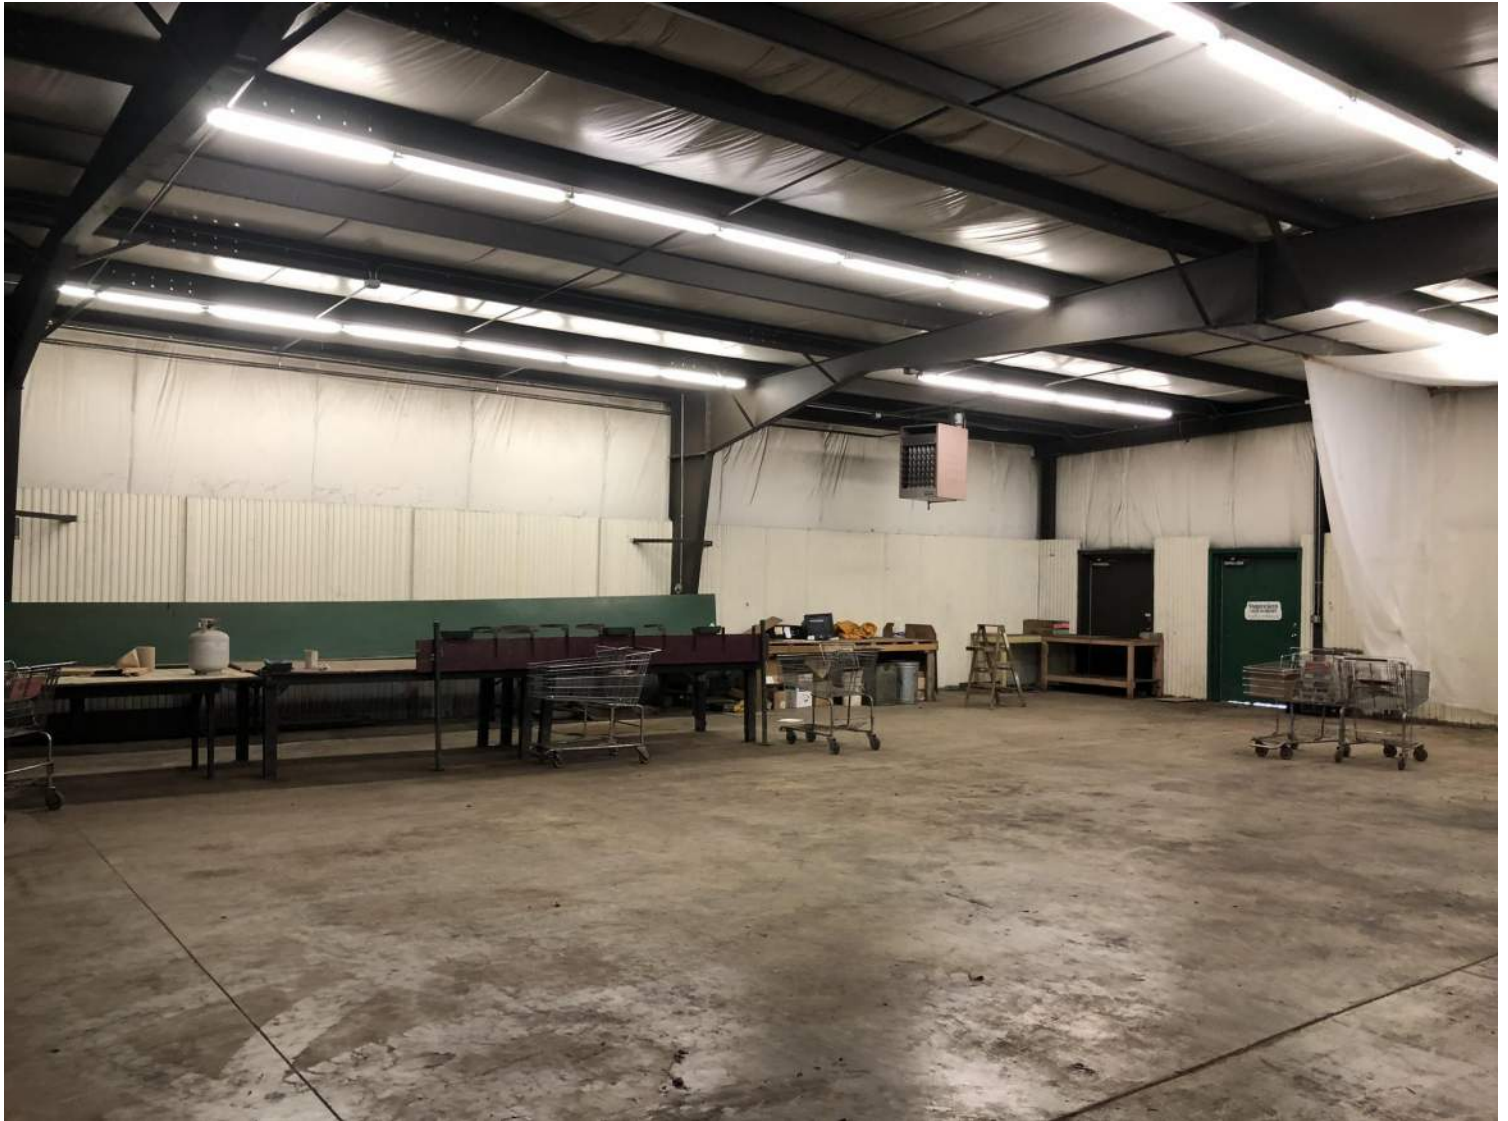
FIGURE 11 - TYPICAL STEEL FRAMING IN THE PRE-ENGINEERED METAL BUILDING (CIRCA 2000).

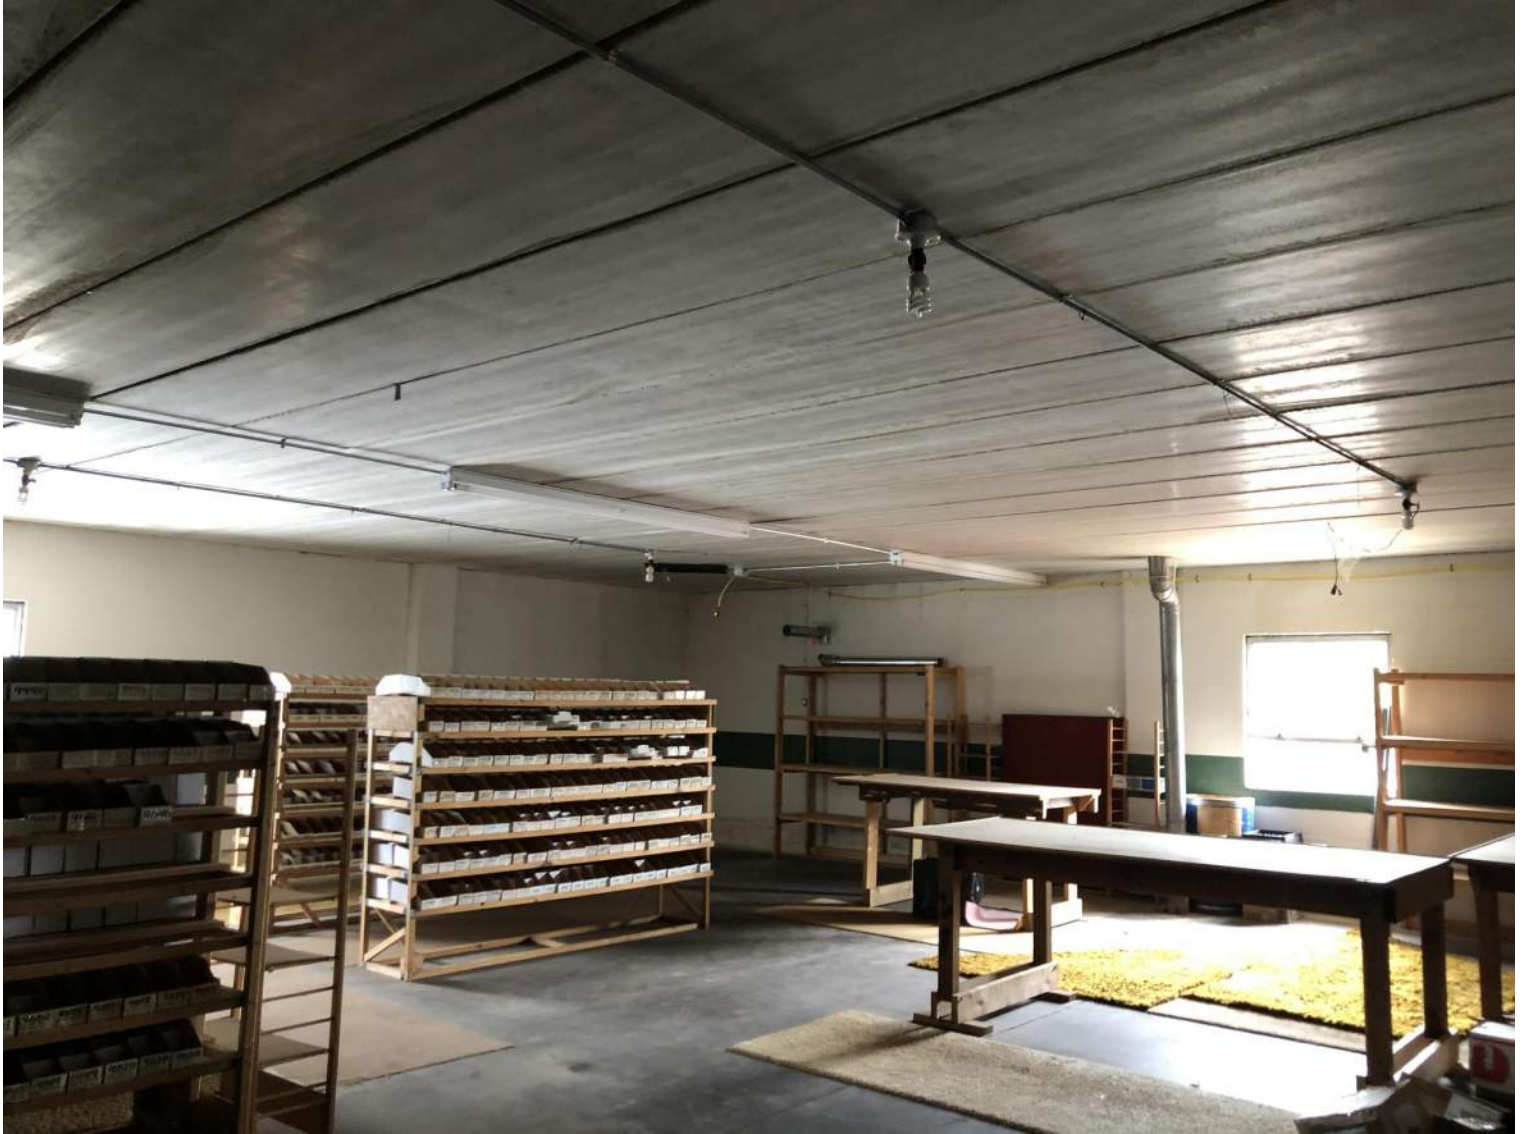
FIGURE 12 - TYPICAL PRECAST CONCRETE FRAMING OF 2-STORY CONCRETE ADDITION (CIRCA 1950s)
