# Faribault Woolen Mill Dam

*Feasibility Study*

Prepared by  
Barr Engineering Co.

May 2026

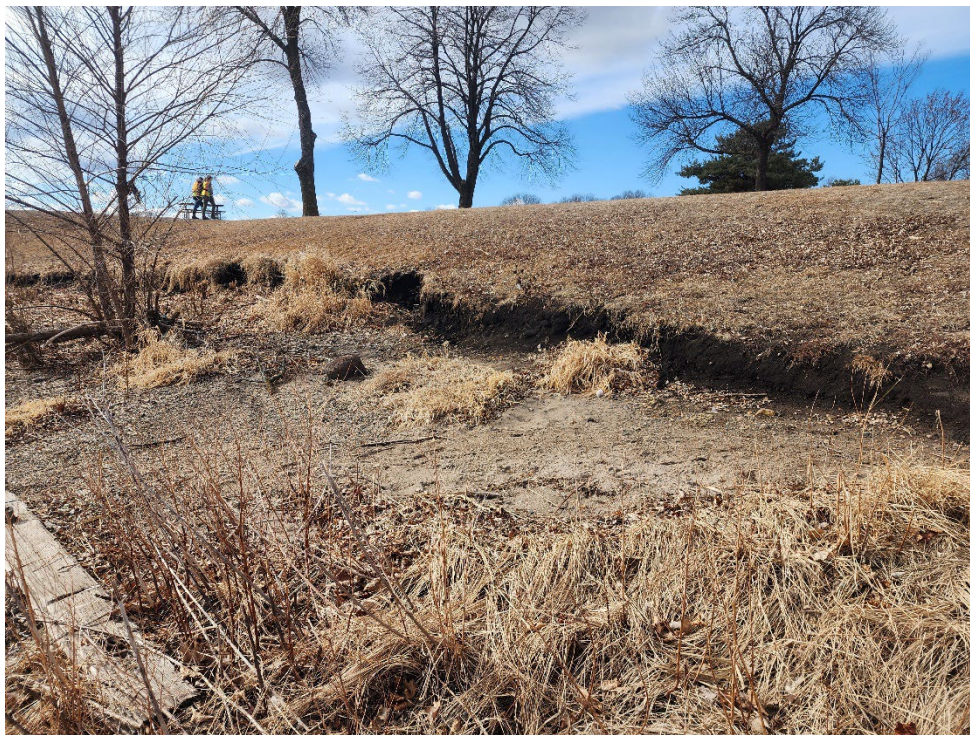
- Downstream channel appears in fair condition. The channel is protected with riprap a few feet above the normal tailwater elevation on both sides. Erosion was observed on the left embankment (Photograph 4) and appeared to line up with historic high-water lines on the mill building wall along the right abutment.
- 2nd Avenue bridge limits flow downstream (Photograph 5).
- Pedestrian timber bridges limit flow downstream and also appear to accumulate debris further limiting flow capacity (Photograph 6).

**Photograph 4 Erosion on the left Embankment of the South Dam**

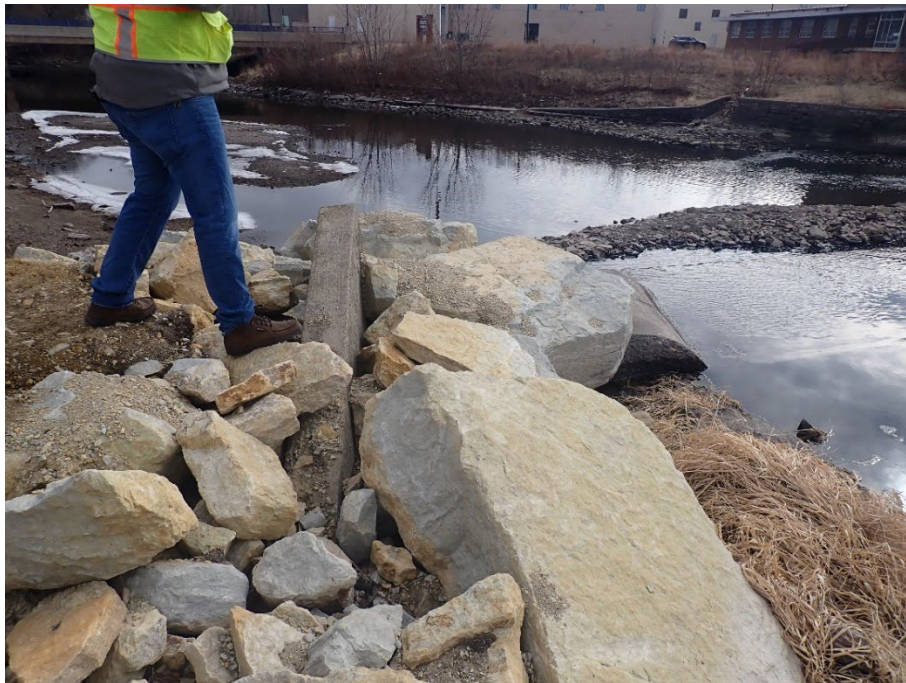
The failed left abutment wall and subsequent rock repair was observed (Photograph 7). Rock was placed both upstream, downstream, and over the left abutment. The concrete wall from the left abutment is visible within the rock. The top of the wall is tilted so as the upstream end is lower than the downstream end, likely indicating a loss of foundation material. At the downstream end of the repair at the elevated concrete walkway, seepage is flowing at a rate greater than 5 gallons per minute from beneath the walkway. A vortex was observed upstream of the left abutment (Photograph 8). Barr completed a dye test by pouring non-toxic, biodegradable liquid dye into the upstream vortex, observing where the dye exited downstream, and timing how long it took to travel downstream. The dye test was performed two times, first with red dye and then with blue dye, and showed that it takes the water just over one minute to move through the left abutment to where it exits beneath the concrete walkway, indicating a clear connection upstream to downstream (Photograph 9, Photograph 10, and Photograph 11).

**Photograph 7 Left Abutment Wall and Rock Repair**

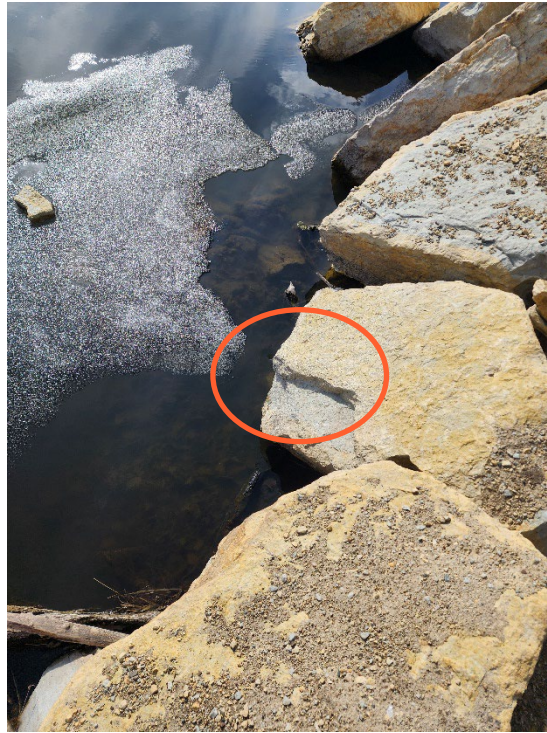
**Photograph 8 Vortex Upstream of the Left Abutment**

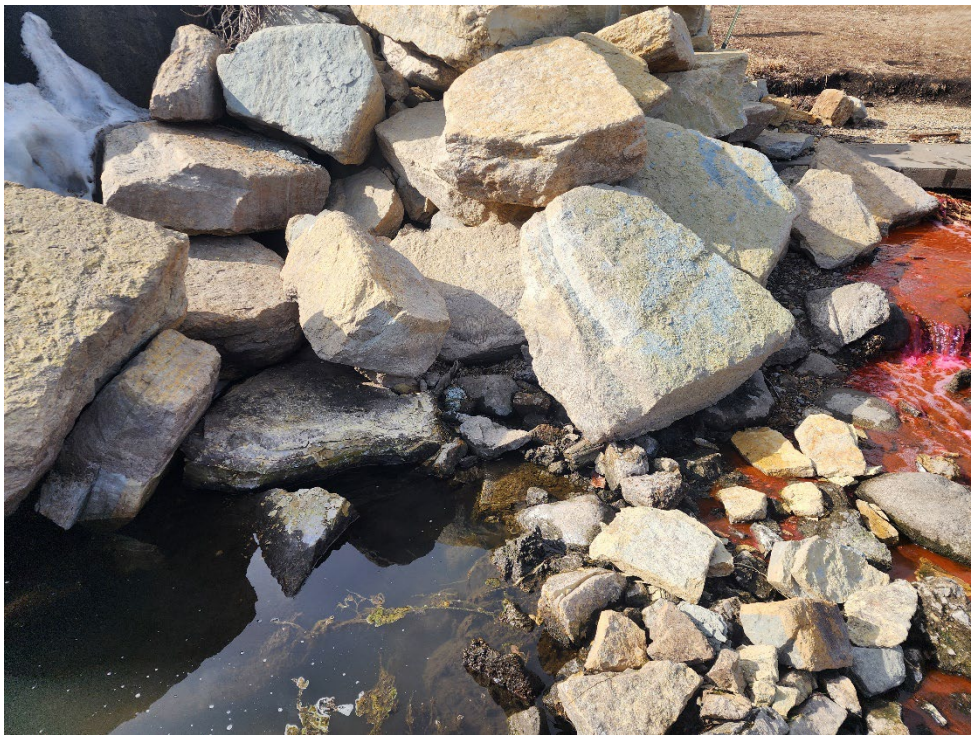
**Photograph 11 Red Dye Traveling through the Left Abutment**

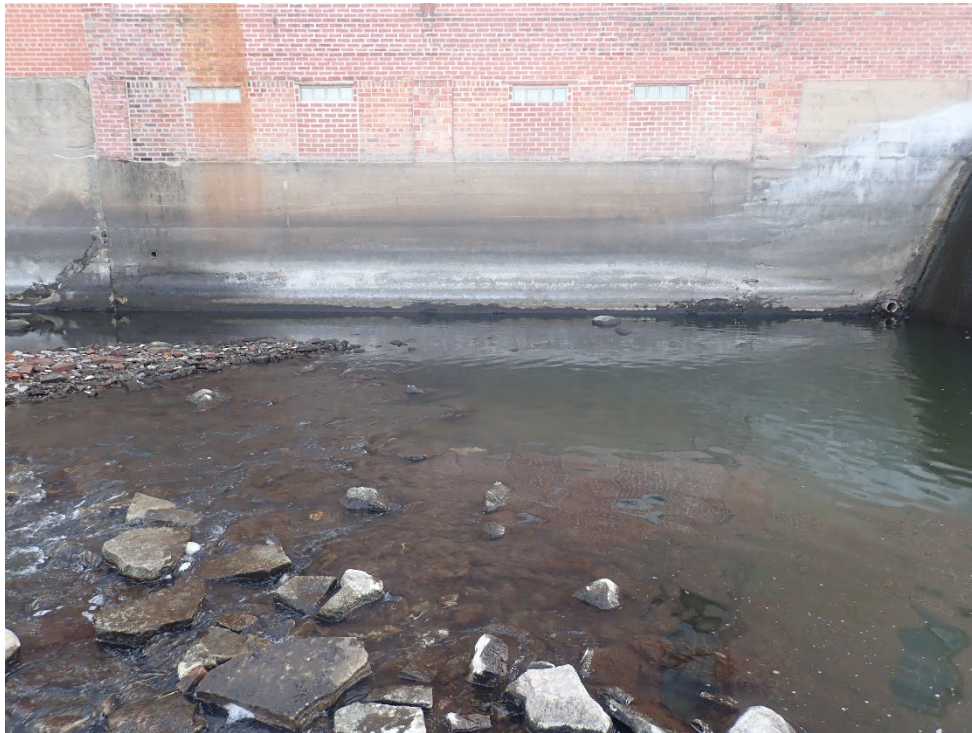
The Faribault Woolen Mill building serves as the right abutment for the South Dam. Barr toured the basement of the mill building and discussed typical conditions as well as flood impacts with Paul Mooty (Partner) and Jeremy Boudreau (Head of Facilities) from the Faribault Woolen Mill. They described how water penetrates the building during flooding events and causes maintenance concerns. Most of the discussion regarding flooding of the mill building was focused on the northwest corner of the building. Although water reportedly enters the building through joints in the exterior brick walls separating the building interior from the river, building personnel have observed that most of the water appears to enter through the floor, suggesting that water penetrates the bedrock and into the building foundation likely due to pressure from the reservoir and tailwater. Barr asked about the drains that appear to be present from the river side of the exterior mill building walls (Photograph 12 and Photograph 13). Mill building personnel reported that these drains are no longer active or functional.

**Photograph 12 Drains on the River Side of the Exterior Mill Building Walls**

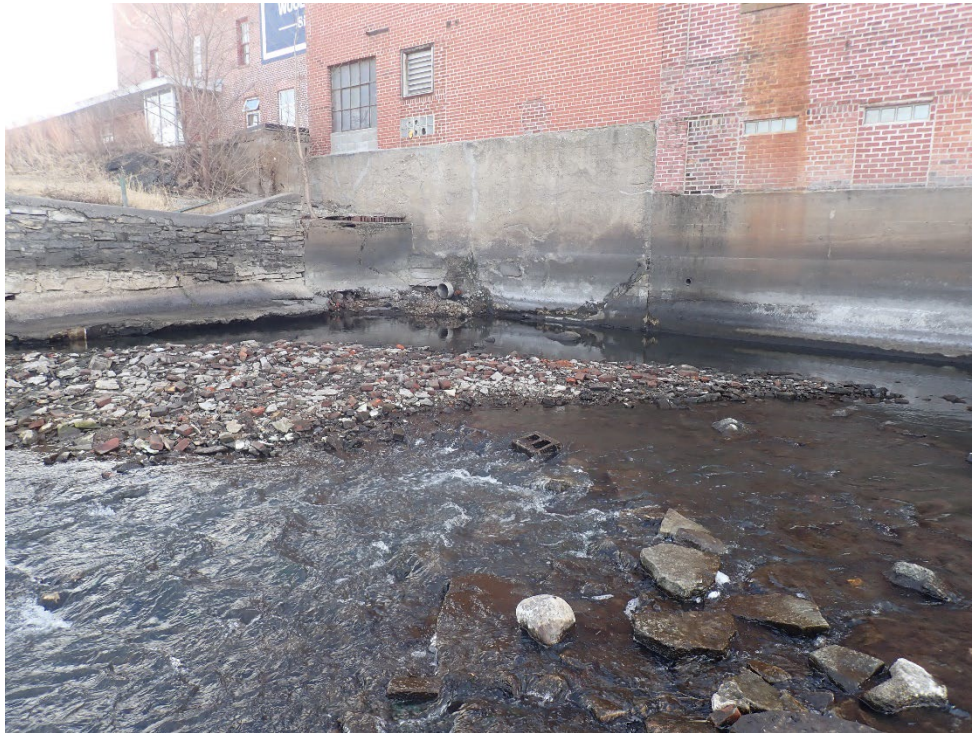
**Photograph 13 Drains on the River Side of the Exterior Mill Building Walls**

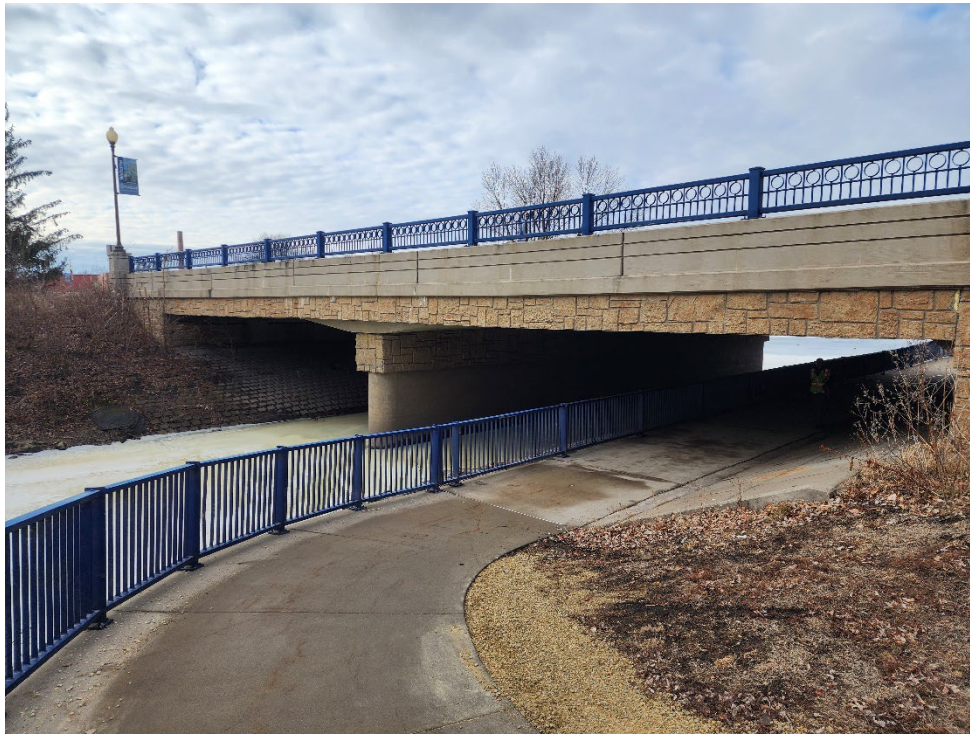
- Downstream channel (earthen slopes) appears in satisfactory condition. The channel is protected with riprap on both sides from the dam to the bridge. Riprap is present at the water line and varies in height. Minor erosion was noted immediately downstream of the walkway about 3-feet above the tailwater.
- A 4" diameter pipe was found on the left slope about 20-feet downstream of the dam and 3-feet above the tailwater. The pipe was partially crushed and filled with mud.
- 2nd Avenue bridge limits flow downstream (Photograph 16).
- Pedestrian timber bridges limit flow downstream and collect debris further limiting flows (Photograph 17).

**Photograph 16 2nd Ave Bridge Looking Upstream at the North Dam**

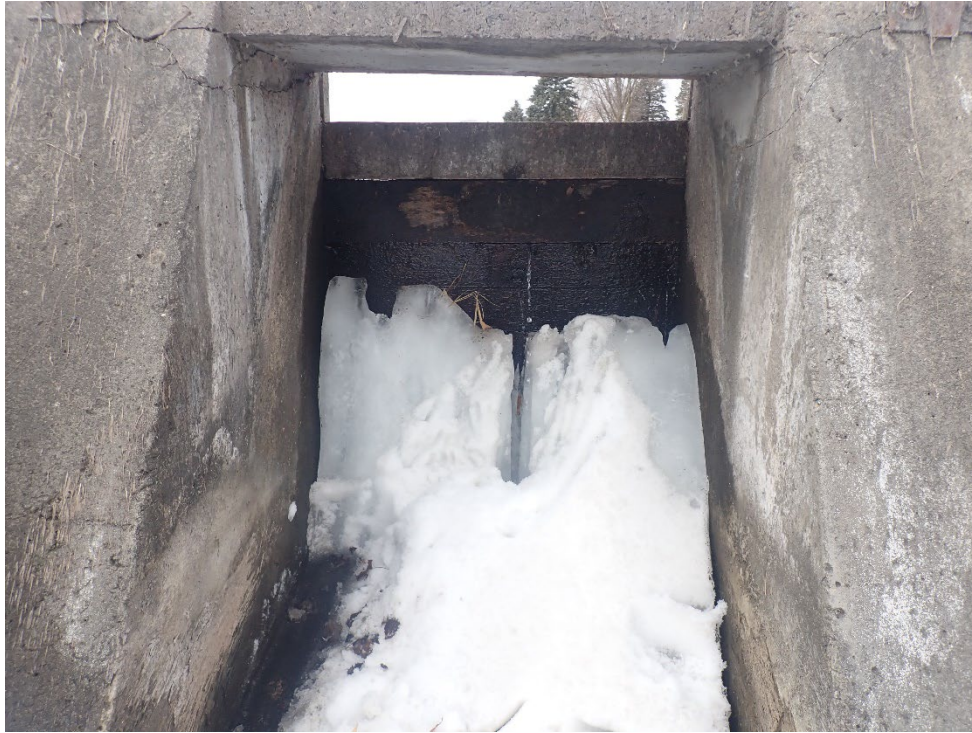
Minor leakage was observed through both the left and right stop logs (Photograph 18). The stop logs consist of rough-cut timber boards approximately 8-inches in height and 4-feet in width. The stop logs are slightly deflected in the downstream direction and do not have lifting rings or a mechanism to allow removal. According to discussions with the city, the stop logs were replaced in approximately the last 5-years but likely cannot be easily removed.

**Photograph 18    Leakage Observed through Stop Logs**

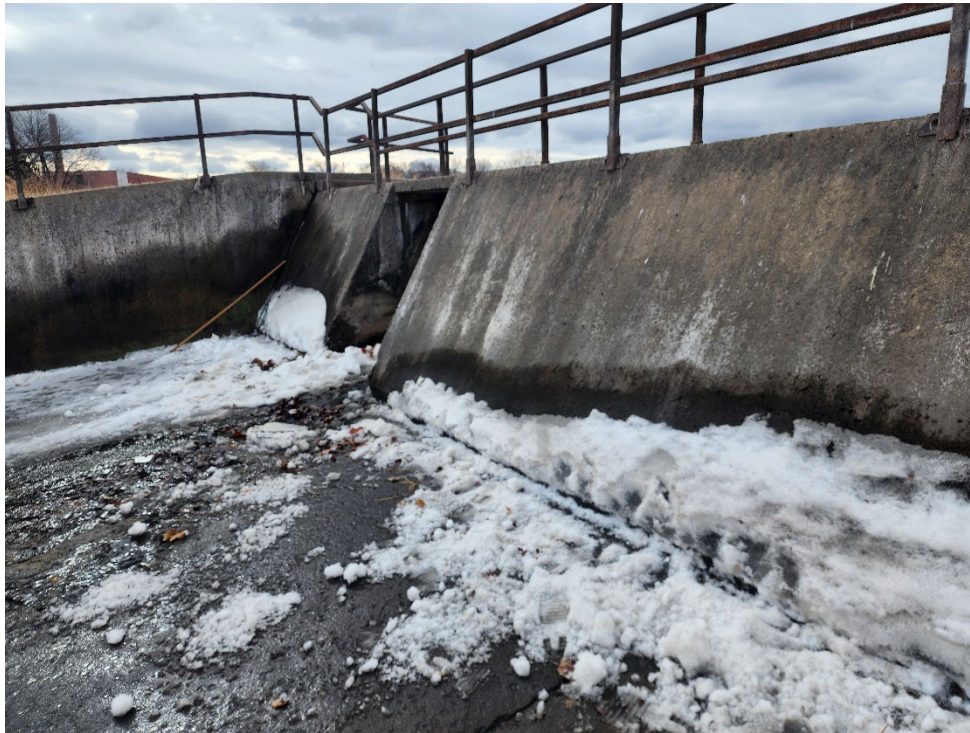
The majority of the joints between the downstream edge of the concrete dams and the base slab appeared to be in satisfactory condition (Photograph 19). There were a couple of exceptions. In one location vegetation growth was observed in this joint, likely indicating separation between the dam and the slab underneath it (Photograph 20). At the ogee overflow section, the joint is tight for about half the distance on the southern side; however, a small gap exists where the ogee ties to the concrete slab on the north half of the spillway. A probe was able to be inserted 3-feet before it hit a solid obstruction (Photograph 21). No visible water was flowing from this gap. A void was also identified beneath the left wingwall (Photograph 22).

**Photograph 19** Typical Joint Between the Downstream Edge of Concrete Dams and the Base Slab

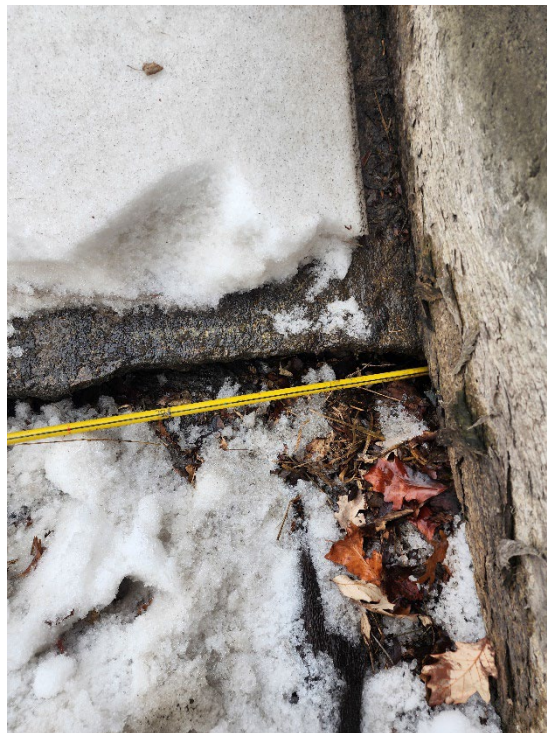
**Photograph 22 Undermining in Joint Between the Left Wingwall of Concrete Overflow Section and the Base Slab**

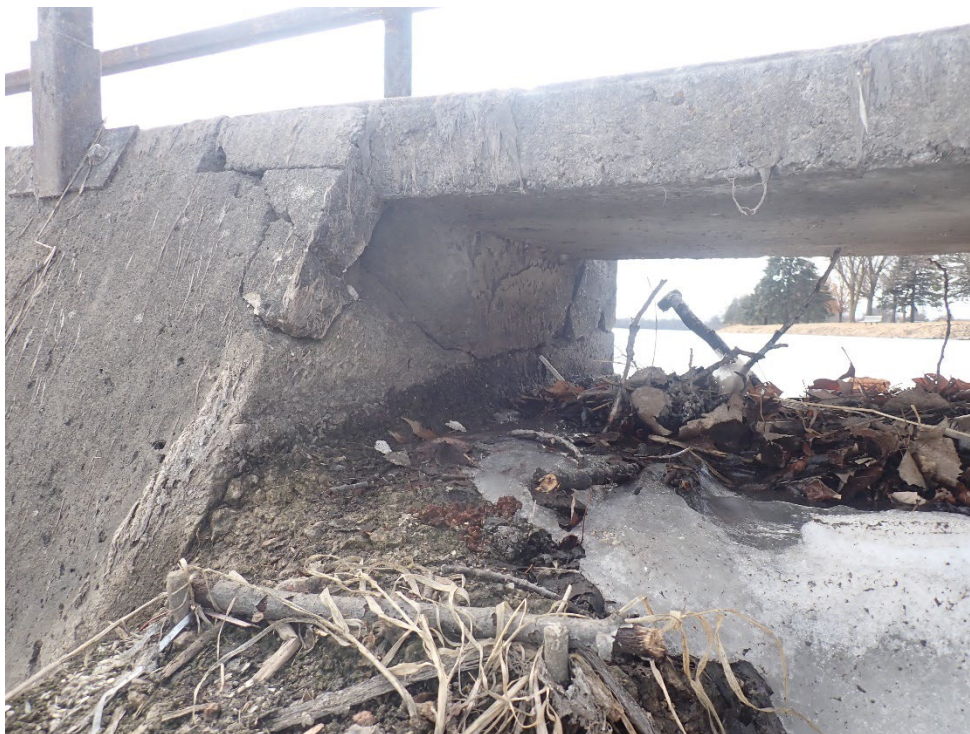
Locations of spalled and delaminated concrete were identified at most locations where the concrete access slab above the dam connects to the gravity dam sections (Photograph 23). Spalled and delaminated concrete, including exposed rebar, was observed in the base slab supporting the concrete dividing wall between the right stop log section and the left overflow section of the dam (Photograph 24). A large void was also observed in the base slab for the dividing wall (Photograph 25). Hammer soundings indicated delaminated concrete along the concrete dividing wall, approximately the first 12-inches down from the top of the wall and the first 5.5-feet along the length of the wall starting from the connection to gravity dam (Photograph 26).

**Photograph 23 Example of Spalled Concrete Near Access Slab Connection to Gravity Dam**

Repairs to the deteriorated concrete would improve the long-term performance of the North Dam concrete structure.

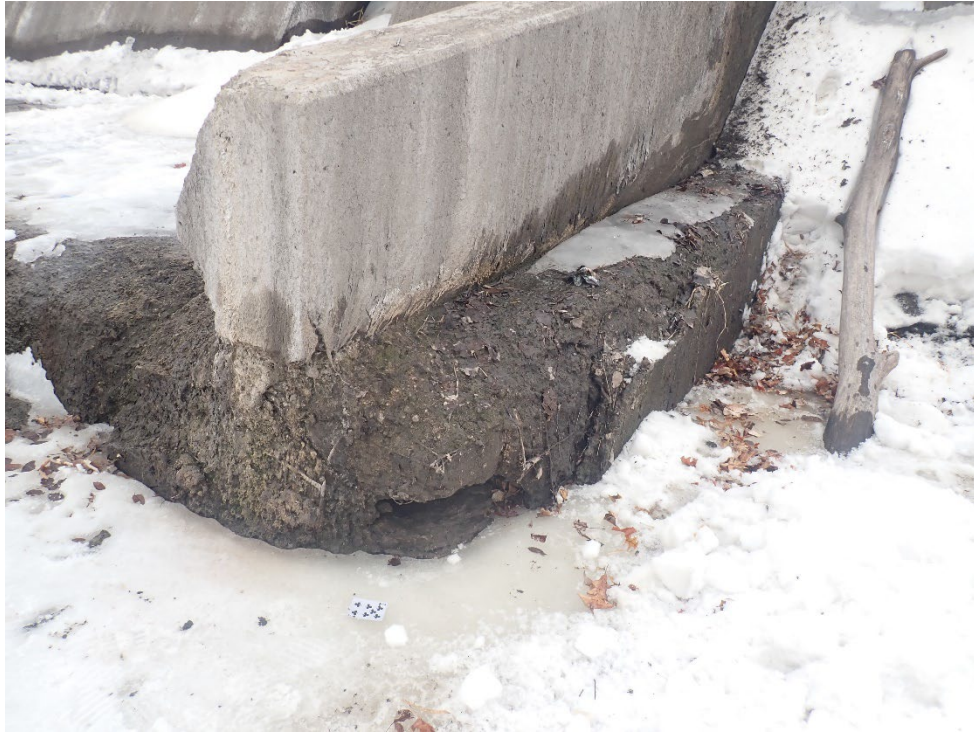
**Photograph 24 Spalled and Delaminated Concrete Between Right Stop Log Section and Left Overflow Section**

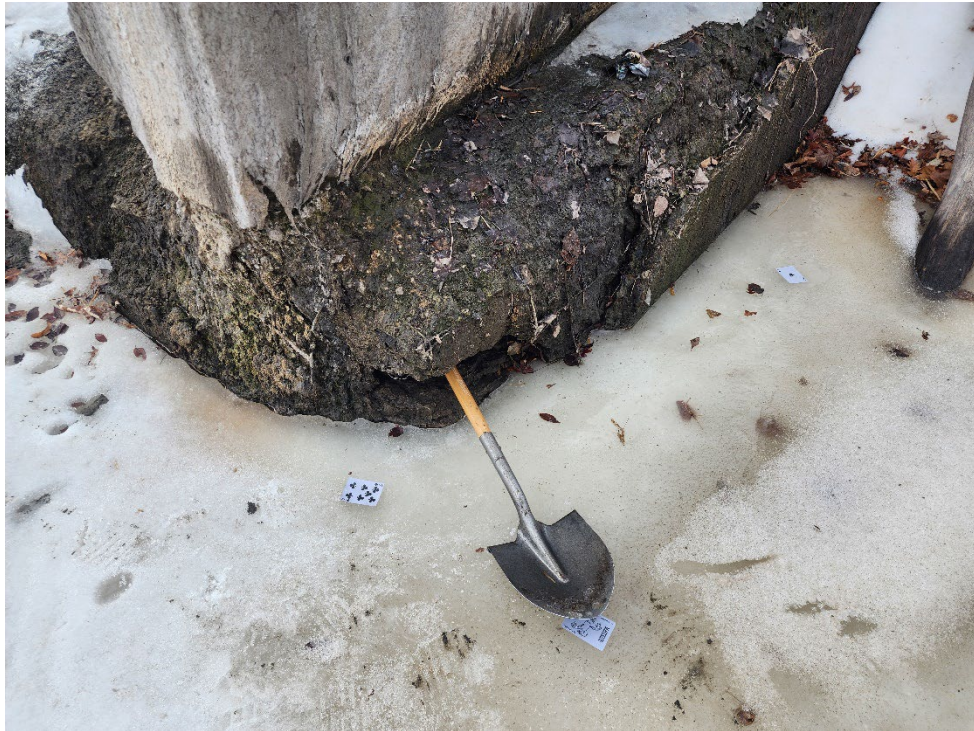
**Photograph 25 Void in Base Slab of Dividing Wall Between Right Stop Log Section and Left Overflow Section**

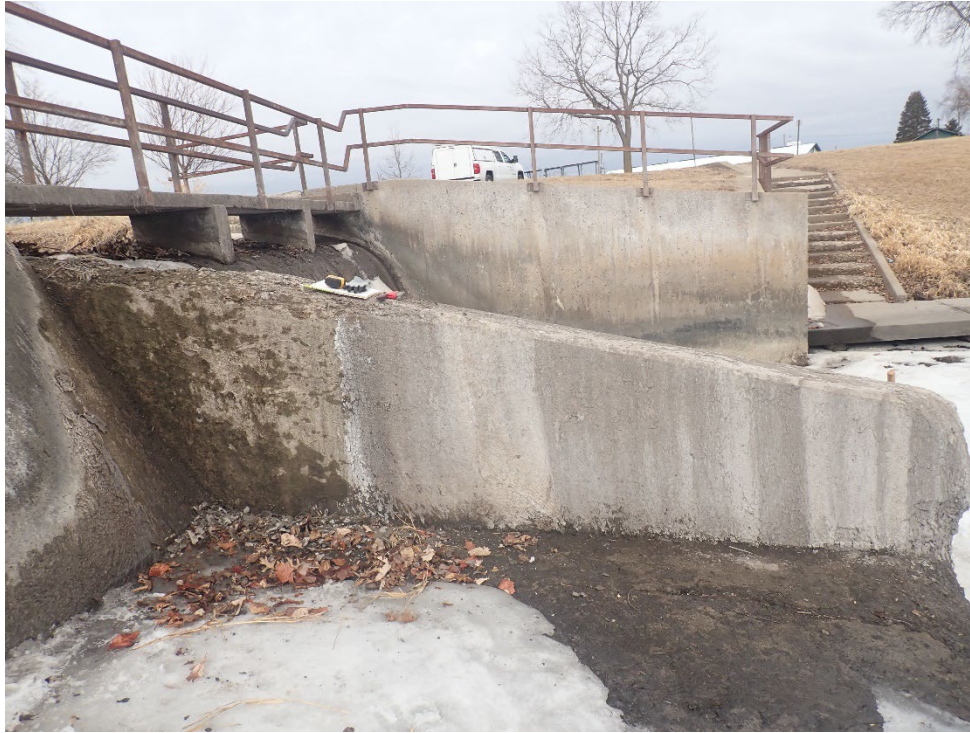
**Photograph 26 Delaminated Concrete On Left of Concrete Dividing Wall and Spalled Concrete on Right (Facing North)**

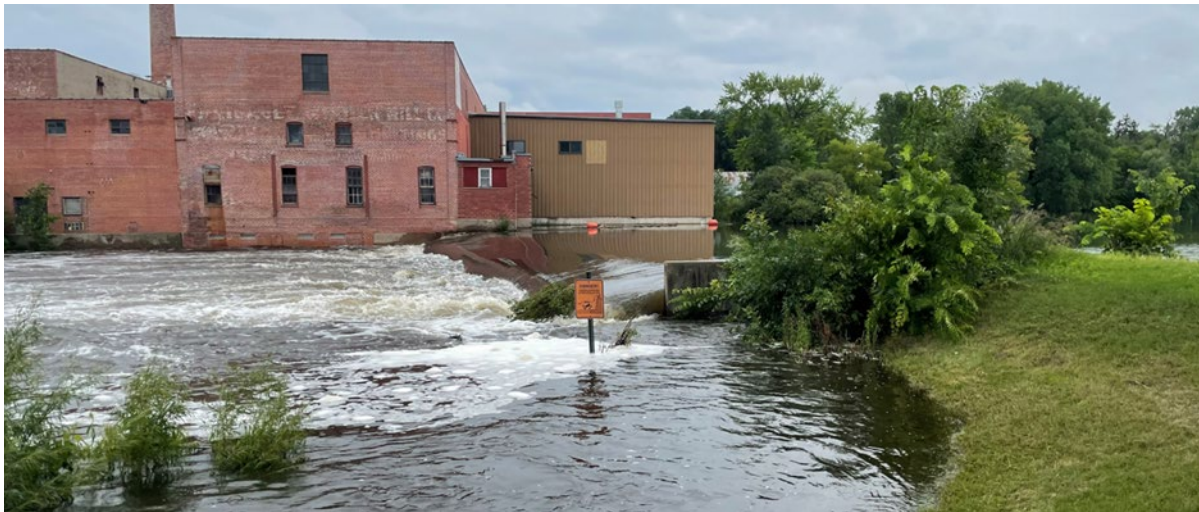
High flows experienced in the Cannon River in June 2024 led to peak flows surpassing 10,000 cfs (USGS Gage 05354500) on June 23, 2024. Visual observation by the City of Faribault on June 28, 2024, documented pre-failure conditions at the left abutment of the South Dam at the Woolen Mills Dam site. Photograph 1 below shows the South Dam on June 23, 2024. Note the left retaining wall still in place.

**Photograph 1** South Dam on June 23, 2024

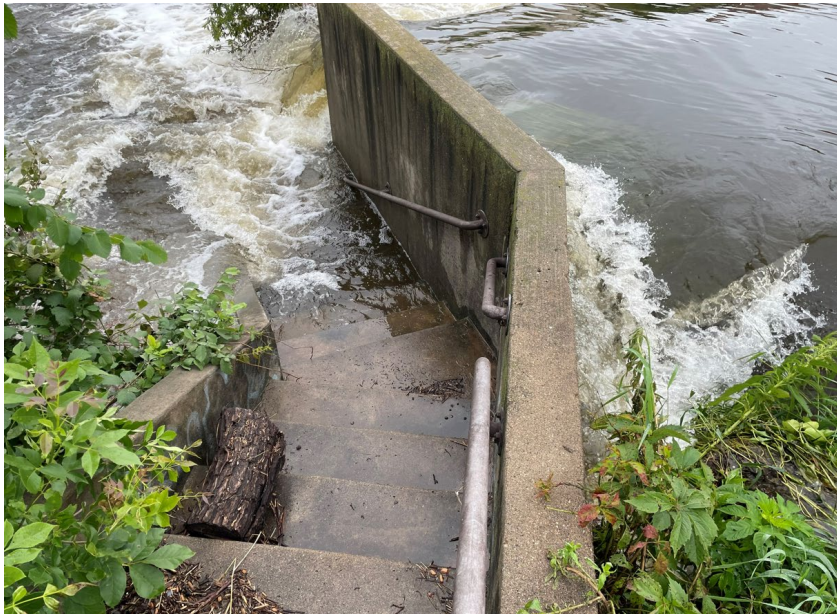
Prior to the failure, water has been noted seeping from below the stairs and retaining wall. Water also appeared to be flowing over the stairs as shown in Photograph 2 taken July 2, 2024.

**Photograph 2 South Dam on July 2, 2024**

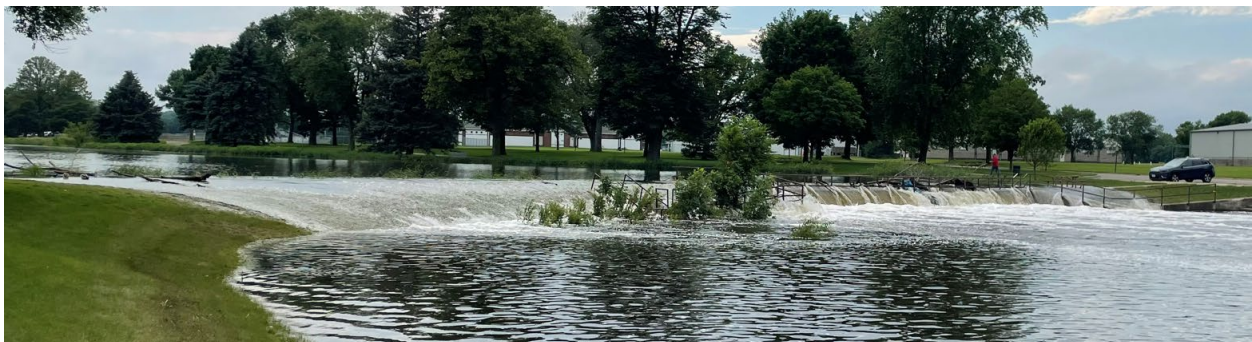
The high headwater was further noted at the North Dam where water had overtopped both abutments as shown in Photograph 3 taken on June 28, 2004.

**Photograph 3 South Dam on June 28, 2024**

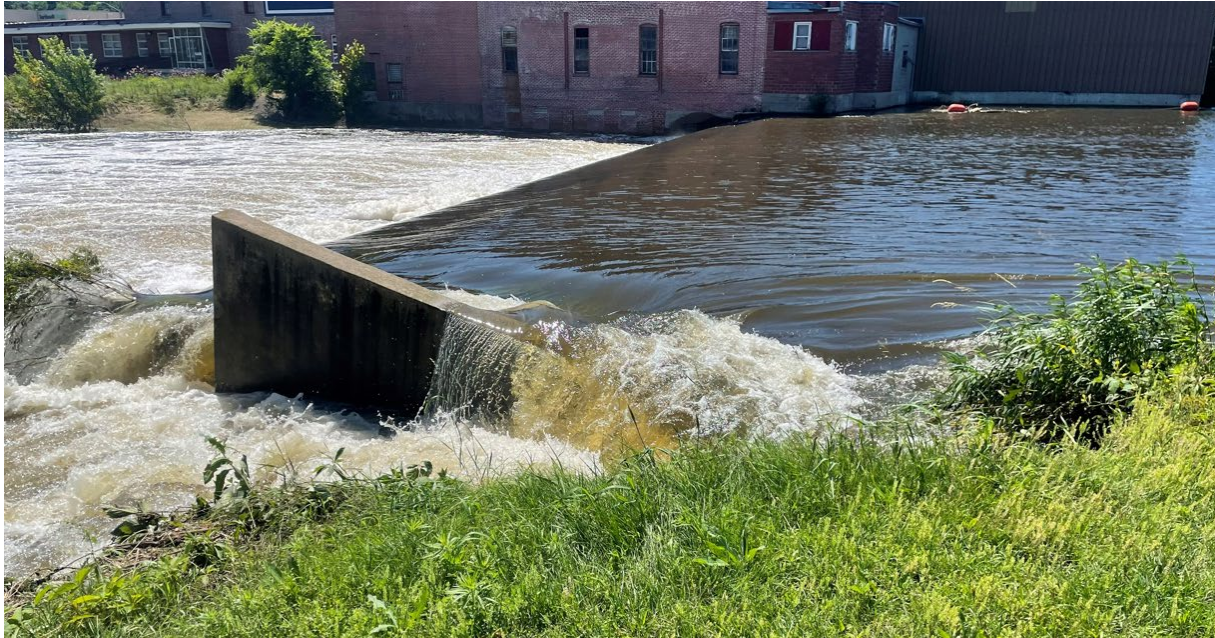
The left retaining wall eventually failed. Photograph evidence appears to show the retaining wall tilted and leaning with the upstream end lower than the downstream indicating a possible loss of material beneath the wall foundation. Water then flowed over and around the top of the wall as shown below Photograph 4 taken on July 3, 2024.

**Photograph 4** Water Flowing Over Top and Around the Wall

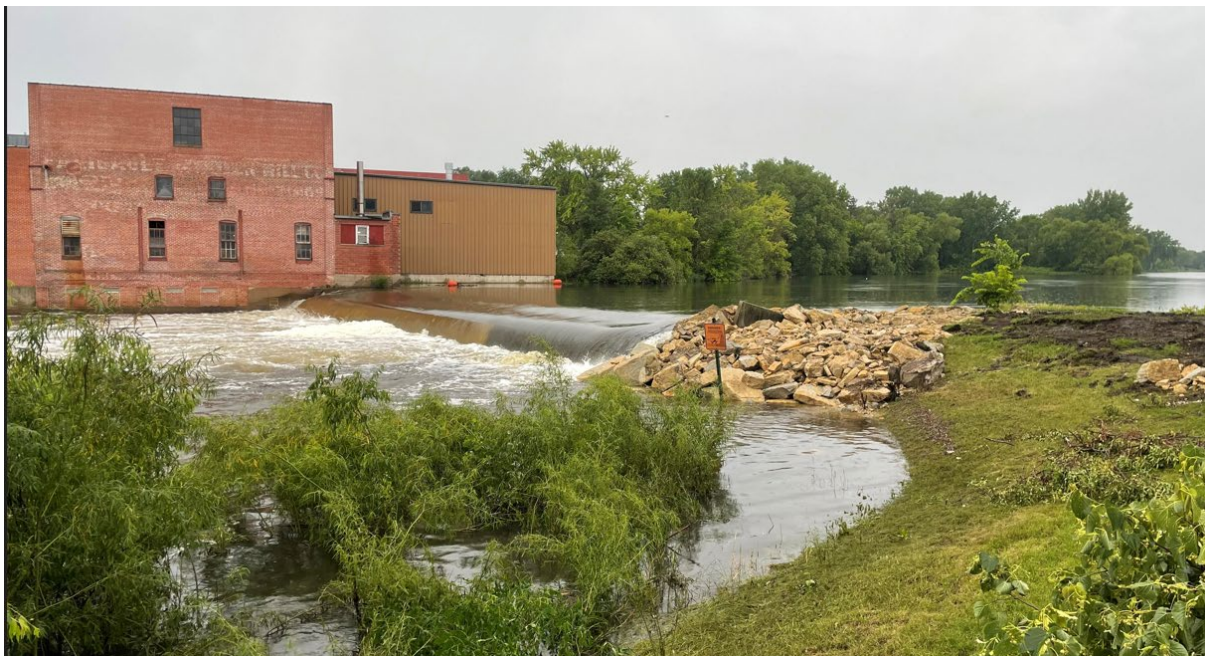
**Photograph 5** South Dam Conditions after the Repair

After the failure occurred, the City of Faribault implemented emergency repairs on July 3, 2024. A combination of rock of varying size with soil was dumped upstream, downstream, and over the left abutment until water was directed over the South Dam. Photograph 5 below shows the conditions after the repair.
