**TO:** Mayor and City Council  
**THROUGH:** Tim Murray, City Administrator  
**FROM:** Deanna Kuennen, Community & Economic Development Director  
**MEETING DATE:** November 2, 2021  
**SUBJECT:** Farmer Seed Building - Potential Redevelopment Discussion

# Farmer Seed and Nursery Company

*Structural Evaluation Report*

*2/4/2020*

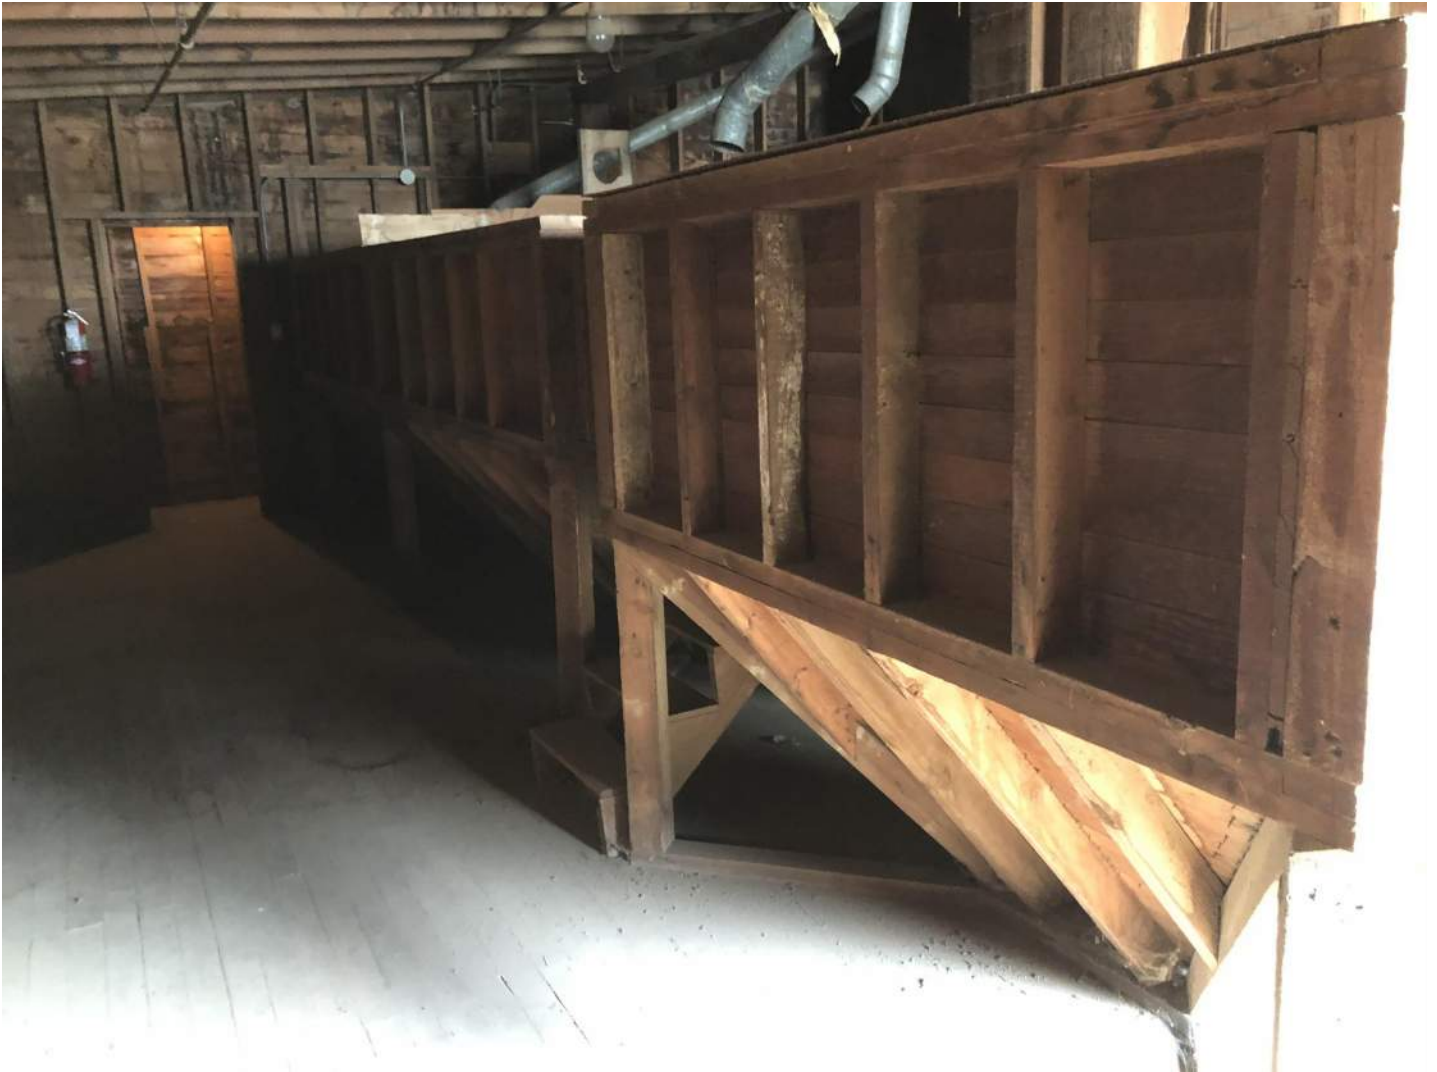
FIGURE 6 - WOODEN HOPPERS USED ON THE UPPER FLOORS OF THE ORIGINAL STRUCTURE.

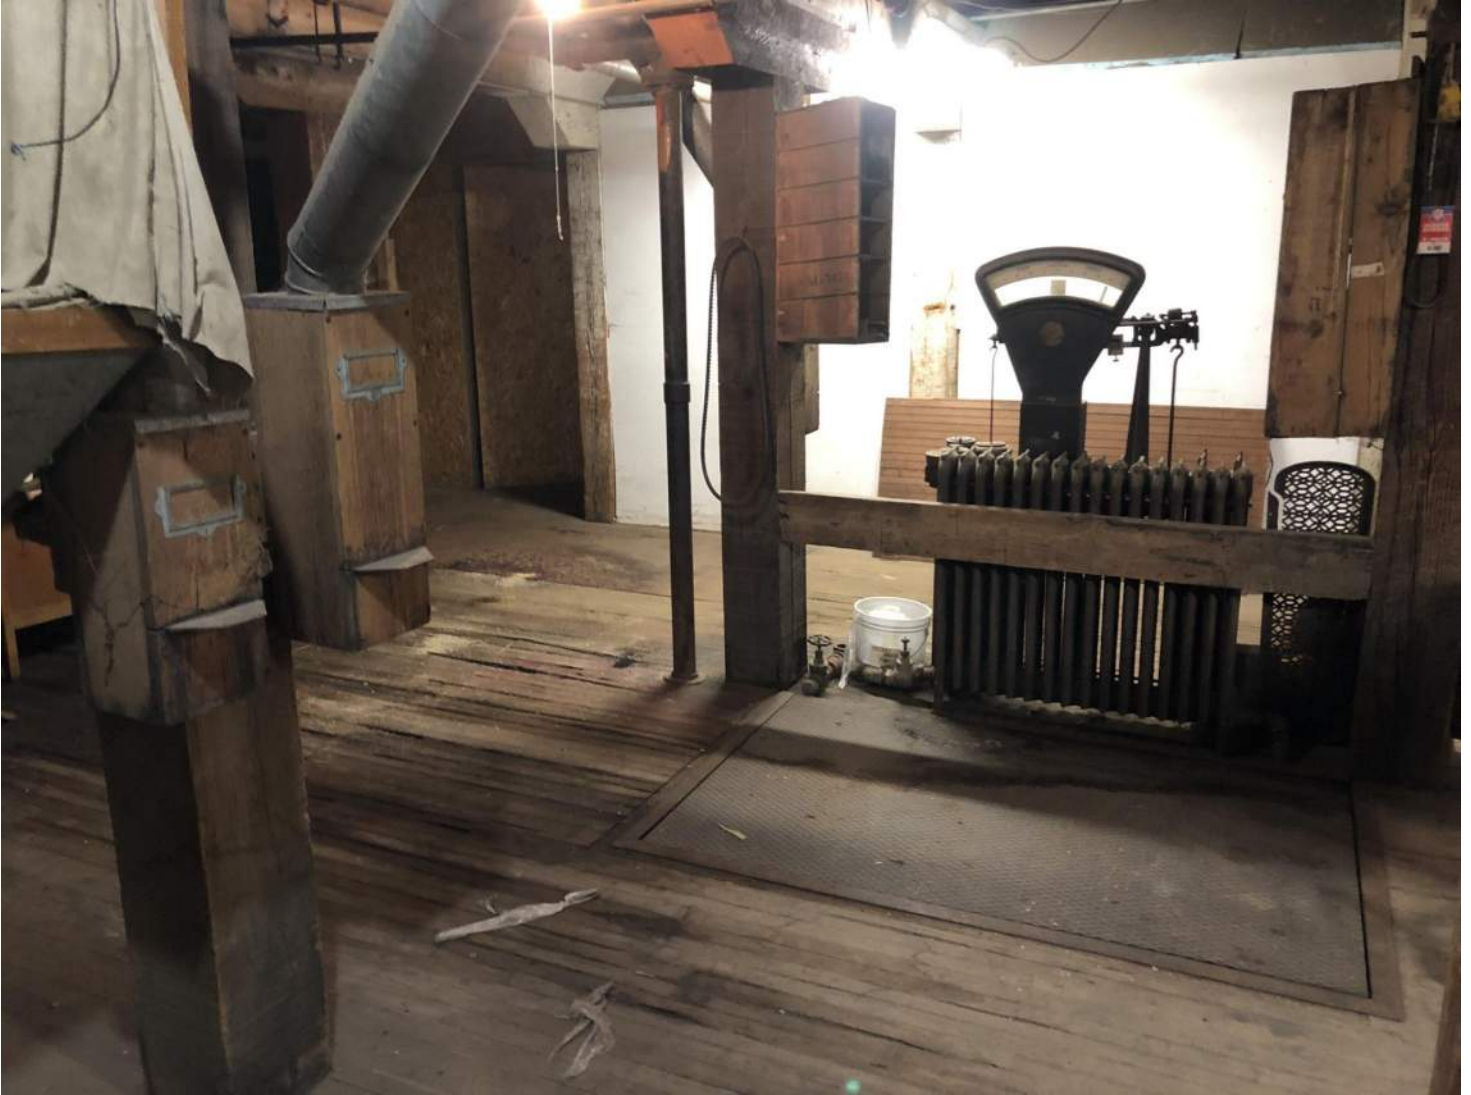
FIGURE 7 - DUCTS AND SEED DISPENSING DEVICES ON THE FIRST FLOOR DIRECTLY BELOW THE MULTI-STORY GRAIN BINS; THE SEED WOULD BE COLLECTED FROM THE DISPENSERS AND THEN PLACED ON THE SCALE SET IN THE FLOOR.

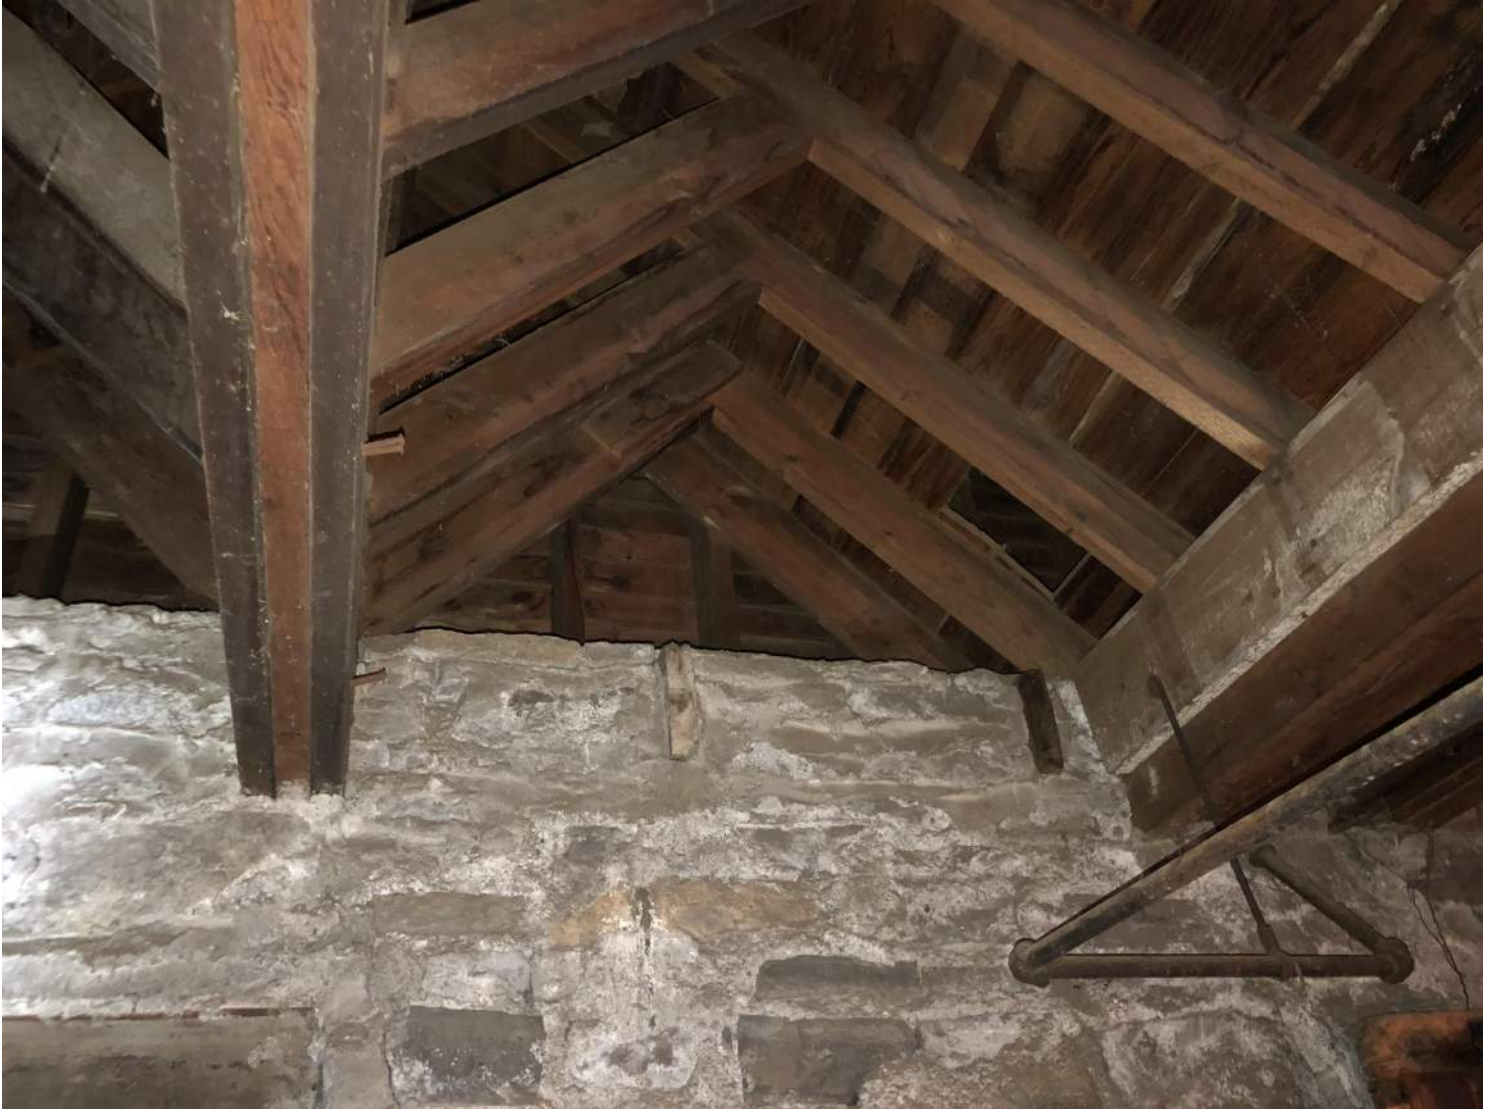
FIGURE 8 - TYPICAL WOOD FRAMING AT THE BASE OF THE MULTI-STORY GRAIN BINS; THIS VIEW IS FROM THE FIRST FLOOR OF THE BUILDING. THE ROCK-FACED FARIBAULT STONE CAN BE SEEN SUPPORTING THE WOOD FRAMING OF THE GRAIN BINS.

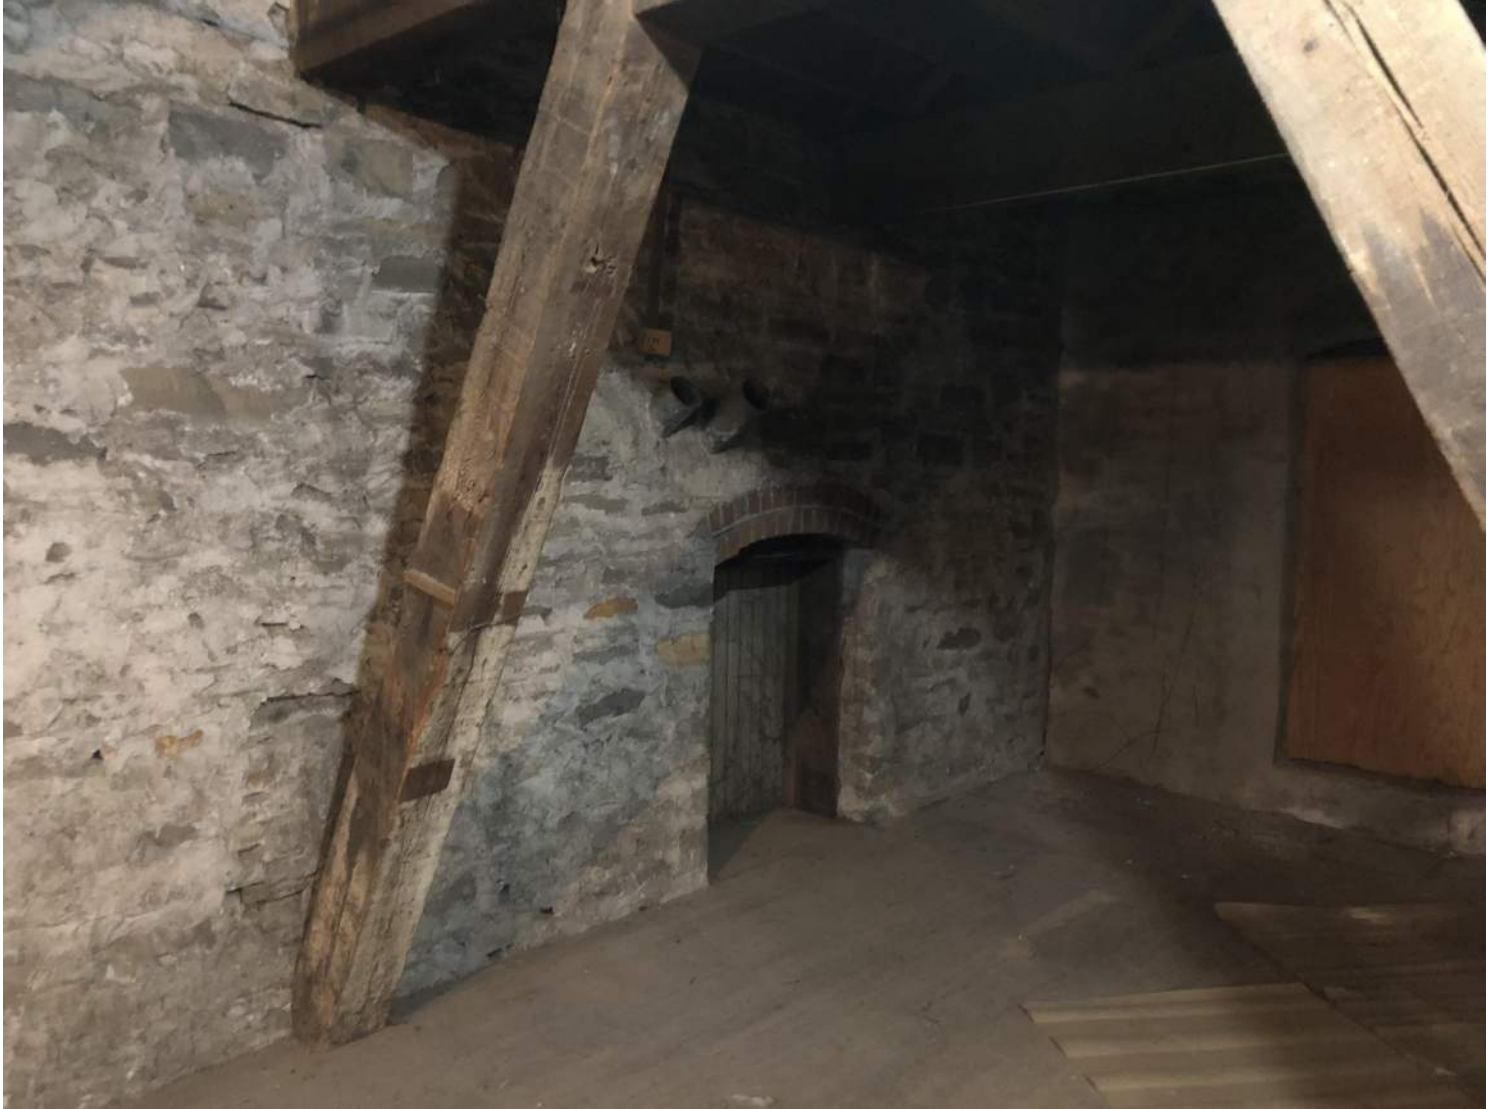
FIGURE 9 - TYPICAL WOOD FRAMING AND BRACING ADJACENT TO A STONE WALL ON THE LOWER FLOORS OF THE MAIN WOOD BUILDING. .

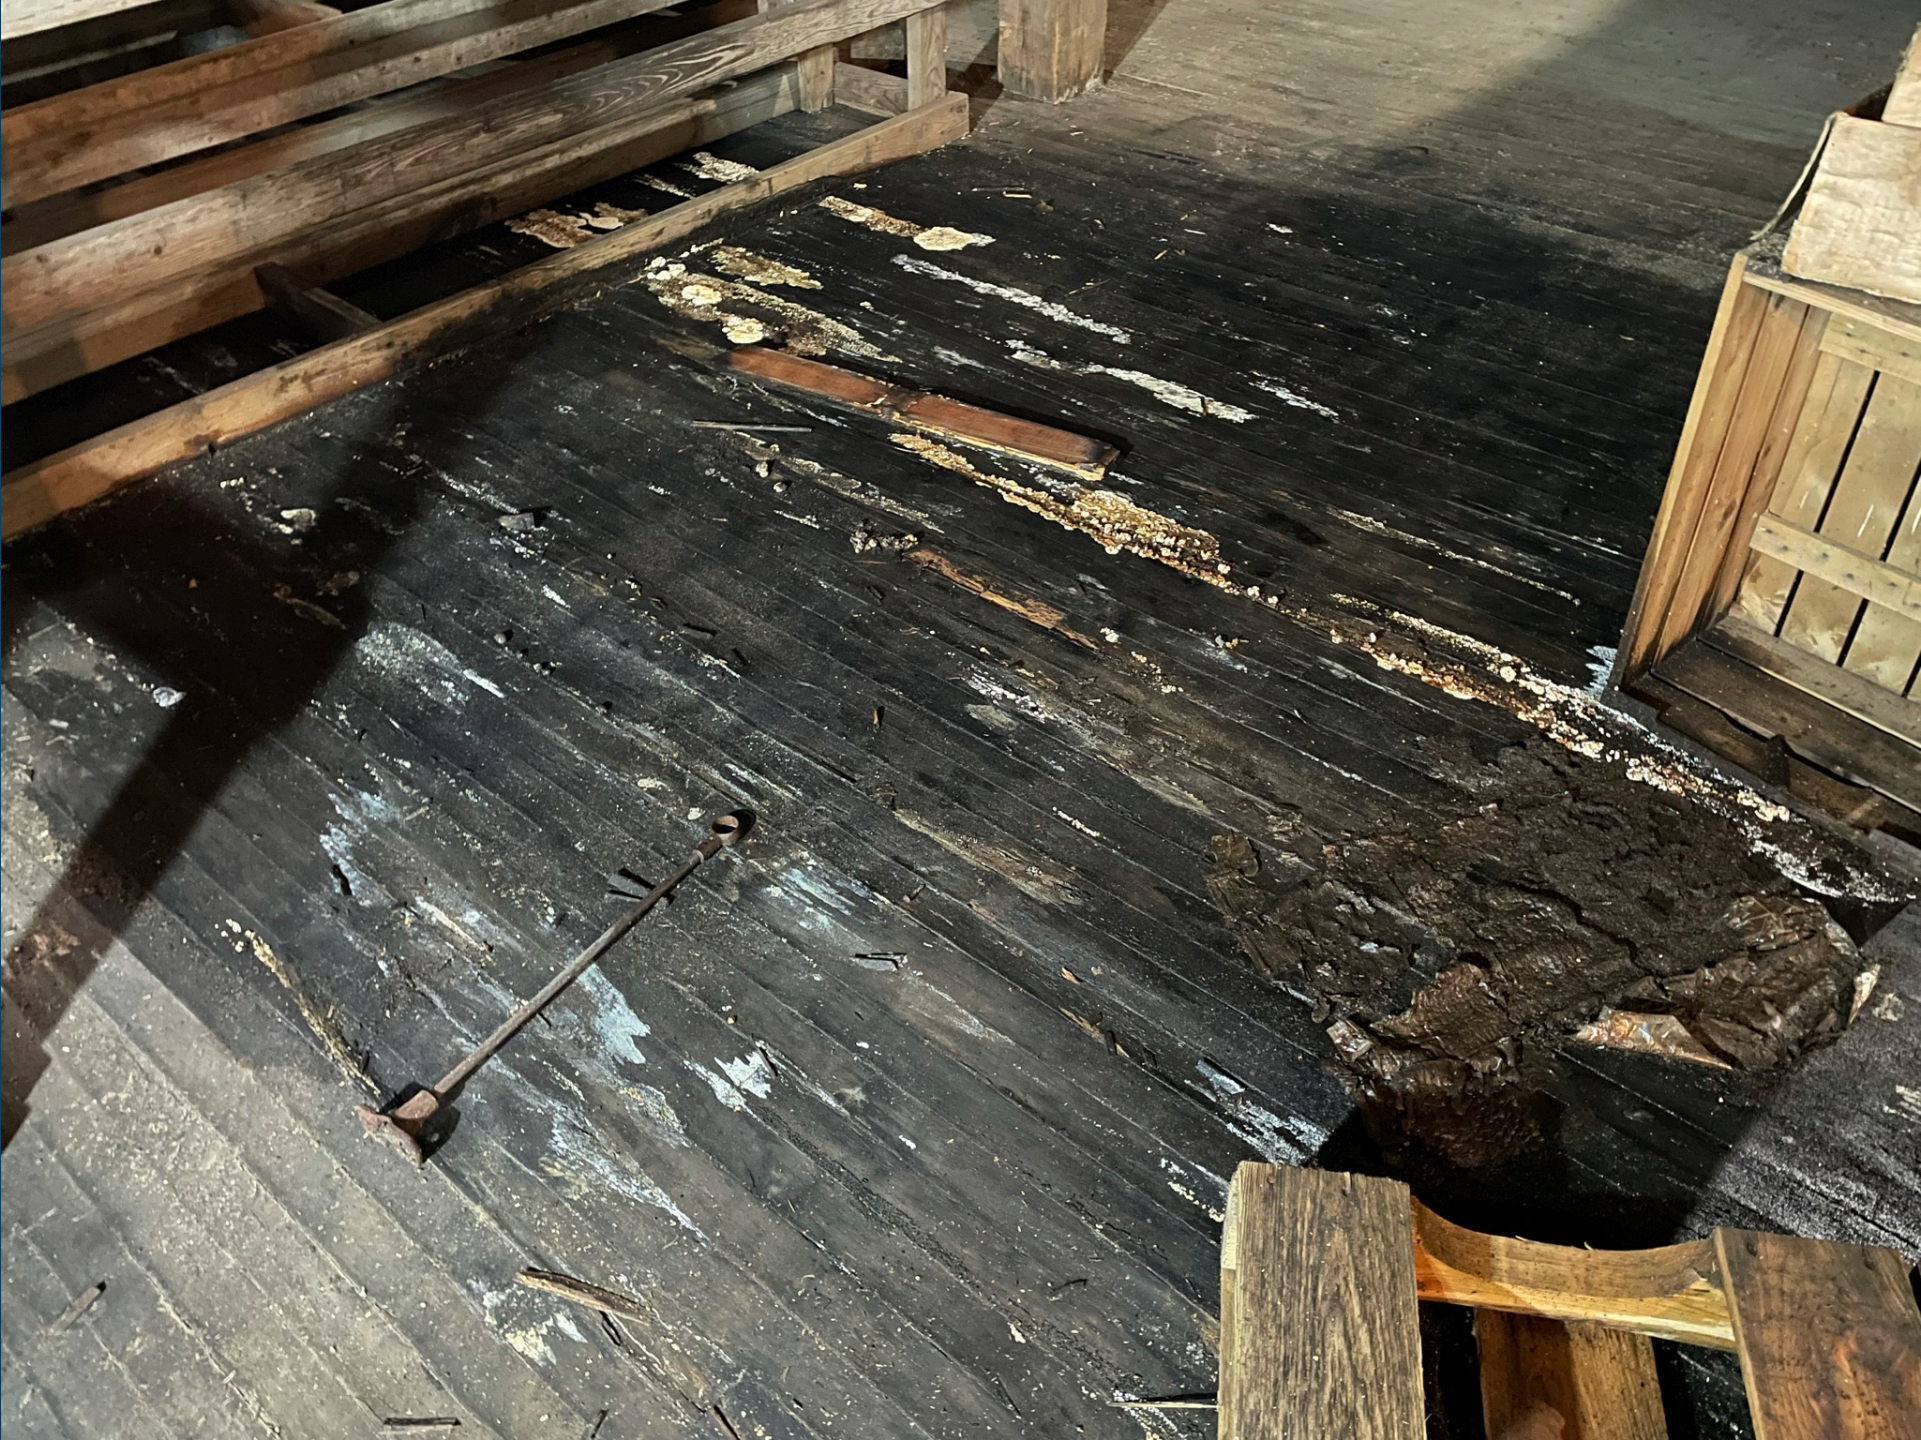
# 2<sup>ND</sup> FLOOR

A25 - FINISHED SPACE WITH DROP CEILING. MOST RECENTLY USED AS OFFICE SPACE.  
A26 - CONVEYOR BELT BETWEEN FLOORS.  
A27 - OLD EXTERIOR WALL. CONSTRUCTED OF WOOD.  
A28 - WOOD FRAMING ABOVE THIS AREA IS GENERALLY IN OKAY CONDITION EXCEPT WHERE MOISTURE DAMAGE IS NOTED.  
A29 - CONCRETE FRAMING IS IN GOOD CONDITION.  
A30 - CELL TOWER EQUIPMENT. FENCE AROUND THIS AREA.

C01 - MOISTURE DAMAGE ON PART OF WOOD FLOOR NEAR HERE. FROM LEAKS ABOVE. FRAMING LIKELY NEEDS REPAIR PRIOR TO FUTURE OCCUPATION OF SPACE.  
C02 - EXTERIOR WALL HAS ONLY METAL SHEATHING ON BARE WOOD STUDS. NO SHEATHING ON INTERIOR STUD WALL; NEW SHEATHING NEEDED PRIOR TO REOCCUPATION OF SPACE. NOTE THAT OTHER ARCHITECTURAL CONSIDERATIONS MAY REQUIRE NEW INTERIOR FINISH/SHEATHING/INSULATION AROUND ENTIRE EXTERIOR.

D01 - OLD VAULT; FLOOR SETTLING AROUND IT BUT NOT CONCERNING. VAULT COULD BE RELOCATED IN FUTURE USES. FLOOR COULD NEED SLIGHT PATCHING ONCE MOVED.  
D02 - ROOFING MATERIAL ON THIS BUILDING COULD BE REPLACED PRIOR TO REOCCUPATION IN ORDER TO IMPROVE LONG-TERM USE OF THE STEEL STRUCTURE.

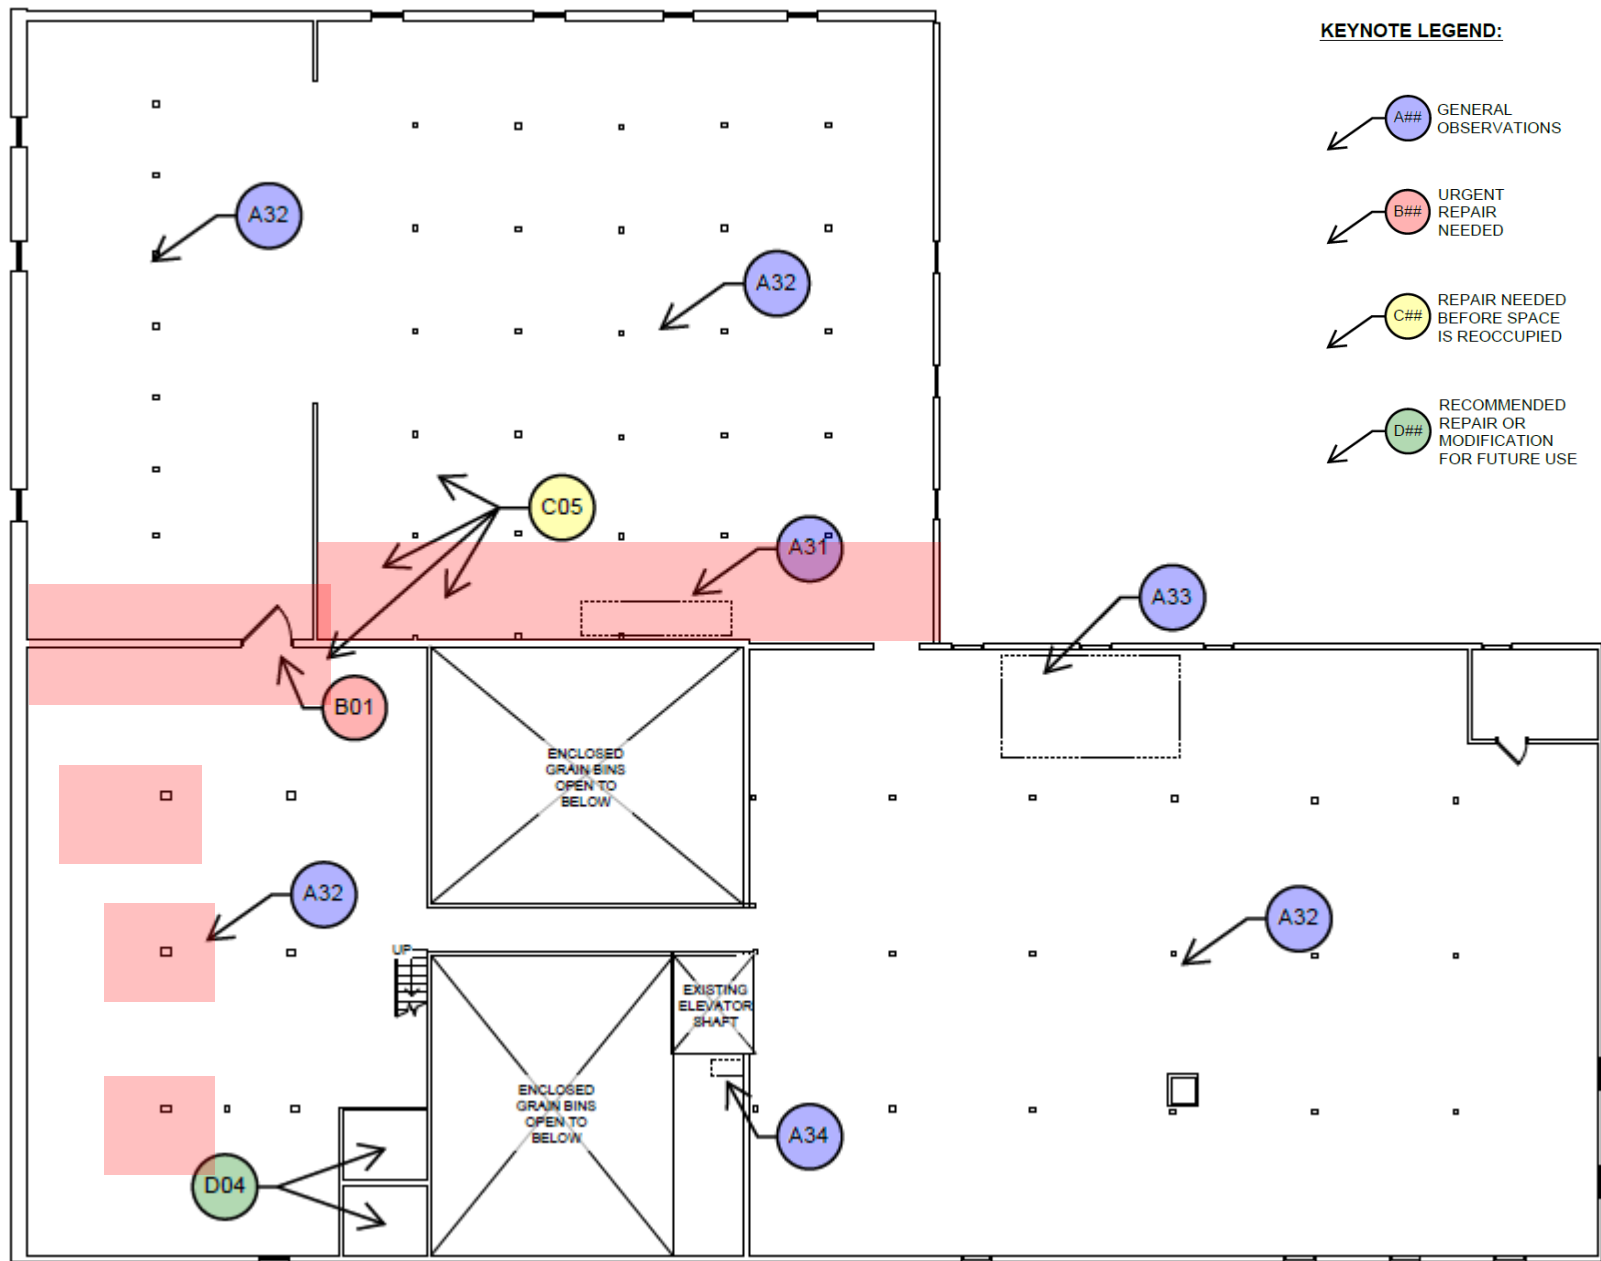
# 3<sup>RD</sup> FLOOR

- A31 - STAIRS BETWEEN FLOORS.
- A32 - WOOD FRAMING IS GENERALLY IN OKAY CONDITION EXCEPT WHERE NOTED.
- A33 - APPROXIMATE LOCATION OF EXISTING RESTROOMS.

- A36 - CHUTE FROM ORIGINAL USE PROCESSING SEEDS. HISTORICAL VALUE LIKELY.
- B01 - VISIBLE ACTIVE LEAK IN ROOF ABOVE. WATER IS BEING COLLECTED IN CONTAINERS BELOW THE LEAK. JOIST IS DAMAGED AND SUPPORTED BY PIPING. JOIST AND DECK ARE IN NEED OF URGENT REPAIR TO STOP THE LEAK. THE ROOFING SHOULD BE PATCHED HERE AS SOON AS POSSIBLE TO PREVENT FURTHER LEAKS AND MOISTURE DAMAGE.

- B02 - VISIBLE ACTIVE LEAKS IN ROOF ABOVE 4TH FLOOR HERE. DECK IS DAMAGED AND WATER IS COLLECTING IN CONTAINERS ON 4TH FLOOR. THE ROOFING AND DECK ARE IN NEED OF REPAIRS AS SOON AS POSSIBLE TO LIMIT FUTURE INTRUSION OF MOISTURE. ROOFING SHOULD BE REPLACED IN 2020.

- C03 - MEMBRANE ROOF. NO VISIBLE ACTIVE LEAKS IN NEED OF IMMEDIATE REPAIR, BUT ROOFING SHOULD BE REPLACED IN THE NEXT 1-3 YEARS.
- C04 - ROOF IS HALF MEMBRANE AND HALF CORRUGATED LIGHT GAGE METAL. AGE UNKNOWN AND NO VISIBLE LEAKS. BUT ROOFING SHOULD BE REPLACED SUCH THAT IT IS OF ONE MATERIAL IN THE NEXT 1-3 YEARS. SOME NEW SHEATHING VISIBLE BELOW ROOF.

- C05 - FLOOR BOARDS ARE BUCKLING DUE TO MOISTURE DAMAGE FROM LEAKS IN ROOF AND FLOOR ABOVE. JOISTS AND FLOORING IN THIS GENERAL AREA WOULD NEED REPAIRS PRIOR TO REOCCUPATION OF THE BUILDING.

- C06 - MOISTURE DAMAGE ALREADY VISIBLE IN FLOOR FRAMING BELOW. REPLACEMENT OF SOME FRAMING IS LIKELY NEEDED BEFORE REOCCUPATION OF SPACE.
- D03 - WOOD-FRAMED "MEZZANINE" THAT IS AT SAME LEVEL AS REST OF FOURTH FLOOR. FRAMING IS IN FINE CONDITION, BUT REMOVAL OF THE MEZZANINE IS LIKELY NEEDED TO MAKE THE 3RD FLOOR USABLE AS A FUTURE RESIDENTIAL OR OFFICE SPACE.

- D04 - ADDITIONAL GRAIN BIN SPACE THAT COULD BE MODIFIED TO ALLOW MORE SPACE FOR FUTURE RESIDENTIAL OR COMMERCIAL USES ON THIRD FLOOR.
- D05 - WOOD "CHASES" THAT CURRENTLY HOUSE SOME CELL TOWER EQUIPMENT. CHASES MAY NEED TO REMAIN IN FUTURE LAYOUTS.

- D06 - NOT MUCH HEAD HEIGHT IN THIS AREA. FUTURE RESIDENTIAL USES COULD UTILIZE THIS SPACE AS "LOFT SPACE" THAT MAY REQUIRE SOME OF THE FOURTH FLOOR FRAMING TO BE REMOVED. THIS COULD BE STRATEGICALLY DONE TO AVOID REPLACING SOME OF THE ALREADY MOISTURE-DAMAGE FLOOR FRAMING OF FOURTH FLOOR.

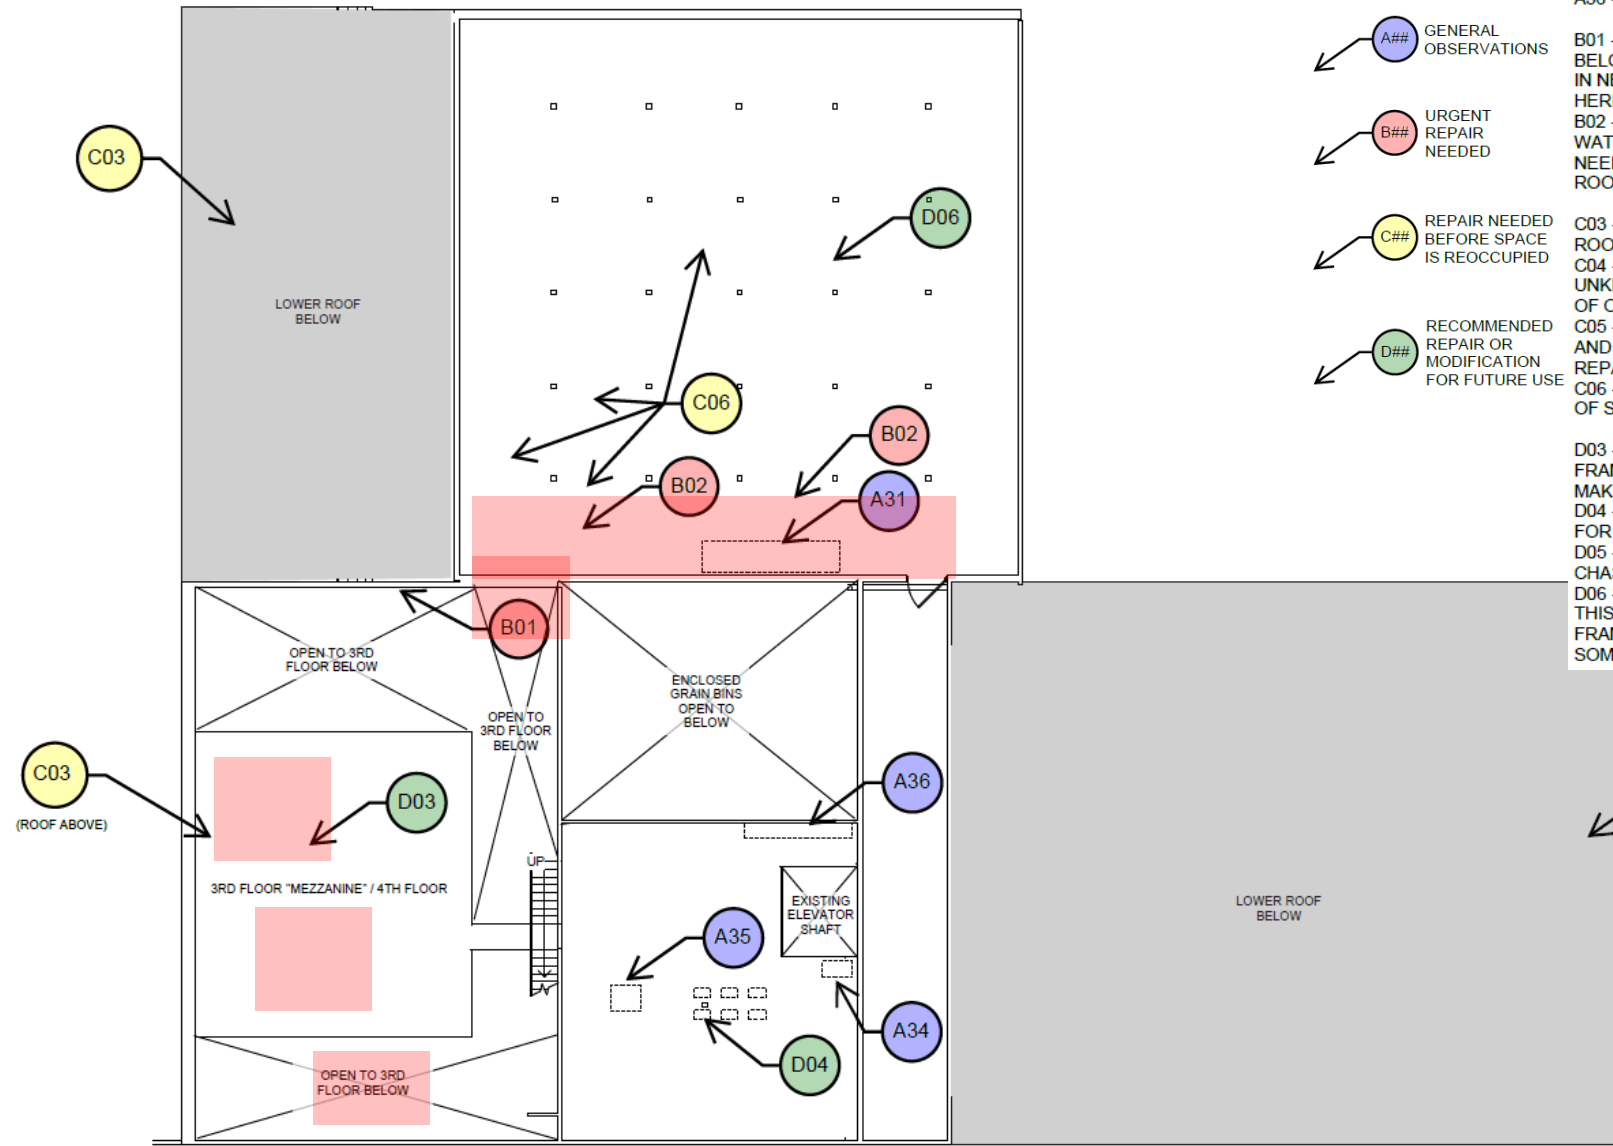
# 4<sup>TH</sup> FLOOR

- A31 - STAIRS BETWEEN FLOORS.
- A32 - WOOD FRAMING IS GENERALLY IN OKAY CONDITION EXCEPT WHERE NOTED.
- A33 - APPROXIMATE LOCATION OF EXISTING RESTROOMS.

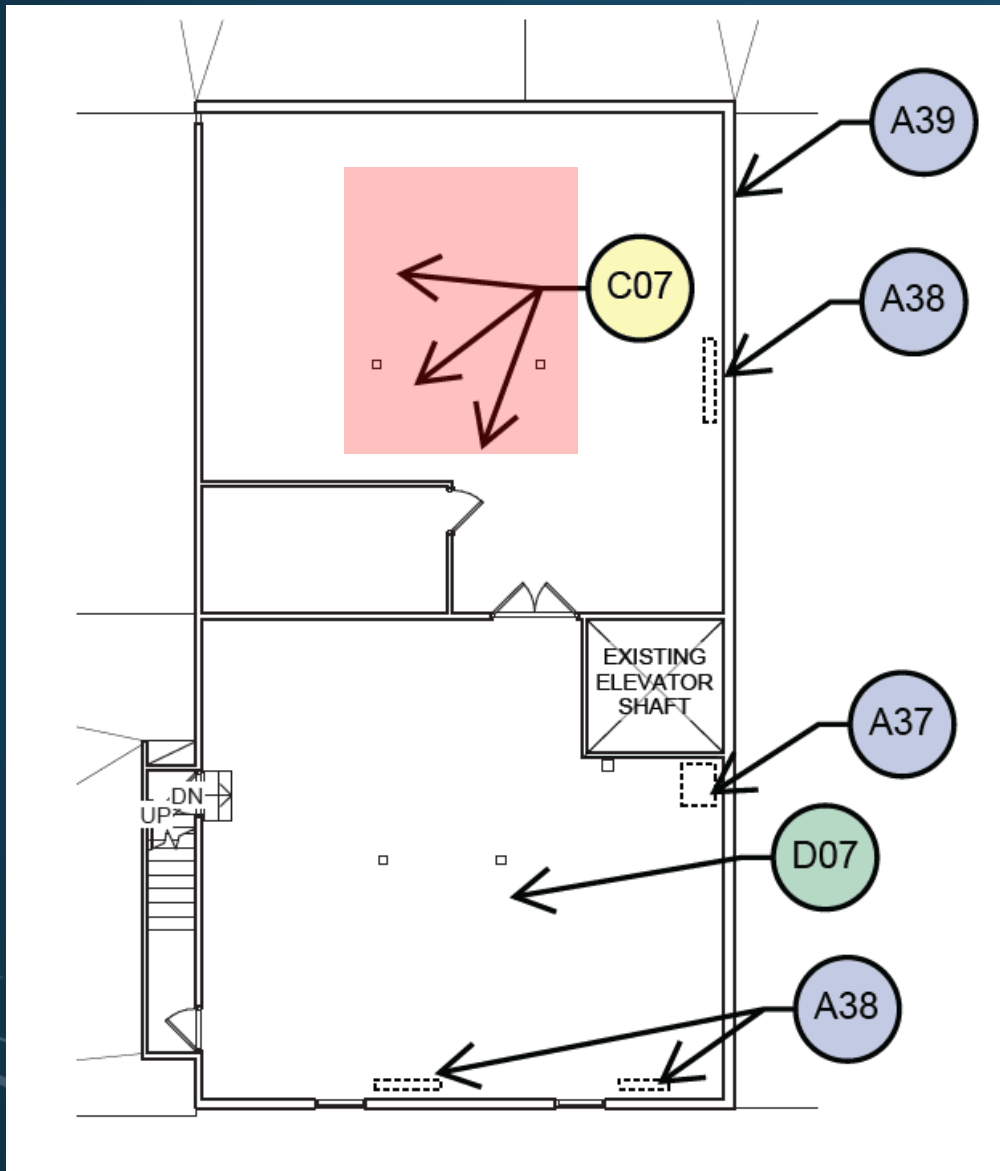
# 5<sup>TH</sup> FLOOR

A37 - APPROXIMATE MURPHY LIFT LOCATION.  
 A38 - OLD RADIATORS. POSSIBLE HISTORICAL FEATURES THAT COULD BE REUSED.  
 A39 - SOME MOISTURE INTRUSION VISIBLE ON PARTS OF EXTERIOR WOOD STUD WALLS. NO MAJOR CONCERNS OR NEED FOR MAJOR REPLACEMENTS OR REPAIRS.  
 A40 - CELL TOWER EQUIPMENT.  
 A41 - HOPPERS STILL IN PLACE. HISTORICAL SIGNIFICANCE COULD FACTOR INTO FUTURE USE OF THIS SPACE.

B03 - VISIBLE ACTIVE LEAKS IN ROOF ABOVE 6TH FLOOR HERE. DECK IS DAMAGED AND WATER IS COLLECTING ON FLOOR BELOW. BLACK MEMBRANE WAS ADDED BELOW THE ROOF TO COLLECT WATER; MEMBRANE IS BROKEN NOW. THE ROOFING AND DECK ARE IN NEED OF REPAIRS AS SOON AS POSSIBLE TO LIMIT FUTURE INTRUSION OF MOISTURE.  
 B04 - ROOFING SHOULD BE REPLACED IN 2020.

C07 - ROTTING FLOOR BOARDS. SOME JOISTS AND DECKING WOULD NEED TO BE REPLACED PRIOR TO REOCCUPATION OF SPACE.  
 C08 - SOME MOISTURE DAMAGED FLOOR FRAMING AND BOARDS MAY NEED REPLACEMENT PRIOR TO REOCCUPATION.  
 C09 - SOME SAG IN ROOF BEAM HERE. NEEDS REPAIR OR REINFORCEMENTS PRIOR TO REOCCUPATION OF THE SPACE.

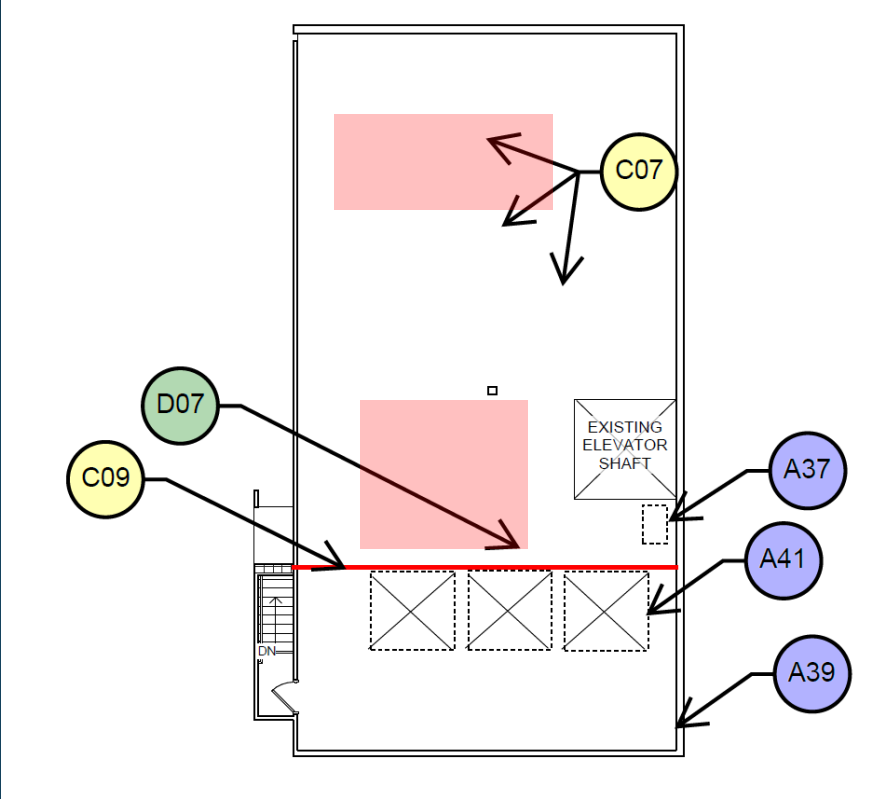
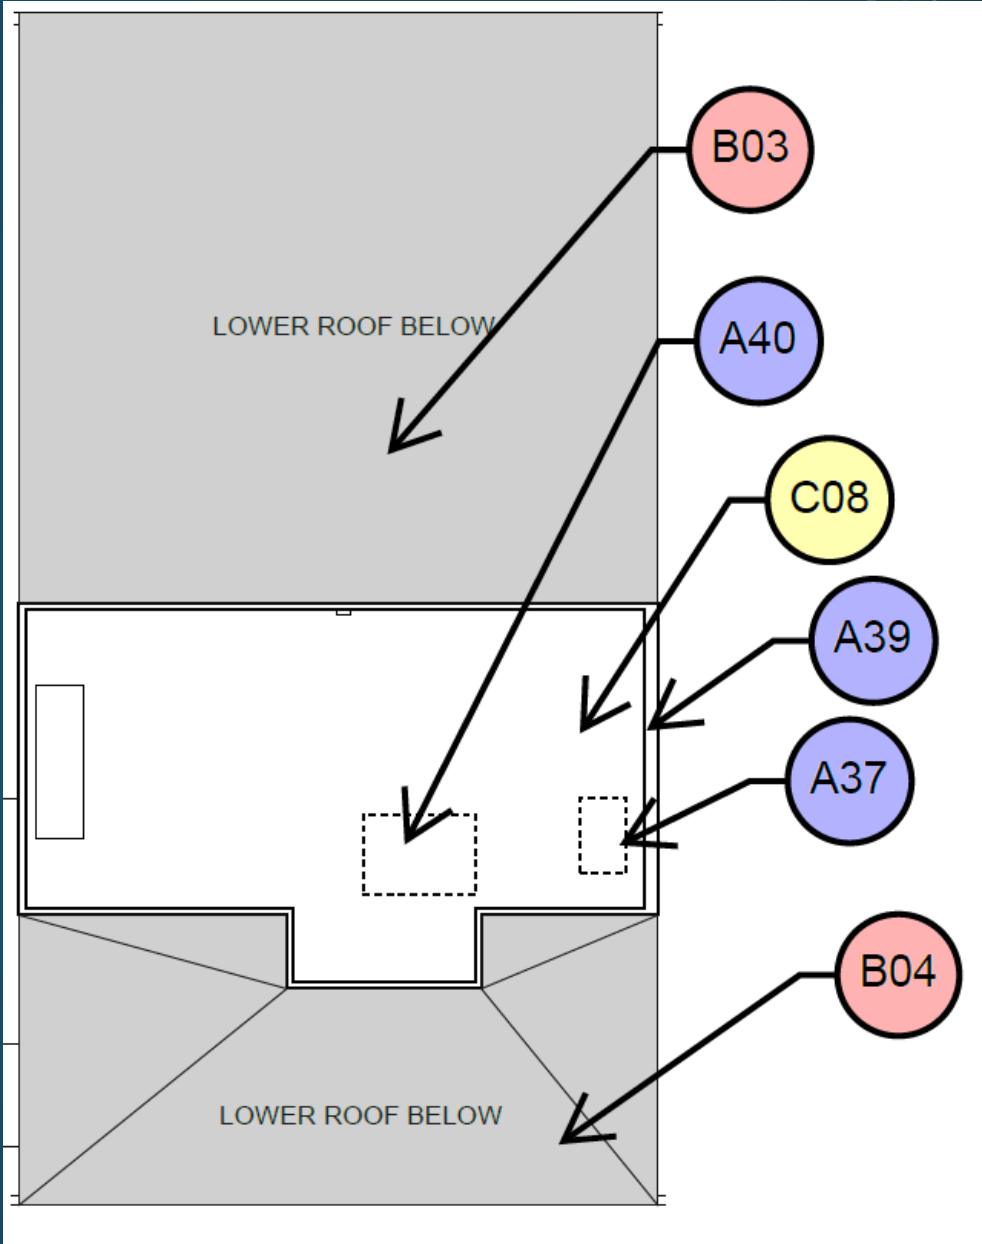
# 6<sup>TH</sup> AND 7<sup>TH</sup> FLOOR

- A37 - APPROXIMATE MURPHY LIFT LOCATION.  
A38 - OLD RADIATORS. POSSIBLE HISTORICAL FEATURES THAT COULD BE REUSED.  
A39 - SOME MOISTURE INTRUSION VISIBLE ON PARTS OF EXTERIOR WOOD STUD WALLS. NO MAJOR CONCERNS OR NEED FOR MAJOR REPLACEMENTS OR REPAIRS.  
A40 - CELL TOWER EQUIPMENT.  
A41 - HOPPERS STILL IN PLACE. HISTORICAL SIGNIFICANCE COULD FACTOR INTO FUTURE USE OF THIS SPACE.

- B03 - VISIBLE ACTIVE LEAKS IN ROOF ABOVE 6TH FLOOR HERE. DECK IS DAMAGED AND WATER IS COLLECTING ON FLOOR BELOW. BLACK MEMBRANE WAS ADDED BELOW THE ROOF TO COLLECT WATER; MEMBRANE IS BROKEN NOW. THE ROOFING AND DECK ARE IN NEED OF REPAIRS AS SOON AS POSSIBLE TO LIMIT FUTURE INTRUSION OF MOISTURE. ROOFING SHOULD BE REPLACED IN 2020.  
B04 - ROOFING SHOULD BE REPLACED IN 2020.

- C07 - ROTTING FLOOR BOARDS. SOME JOISTS AND DECKING WOULD NEED TO BE REPLACED PRIOR TO REOCCUPATION OF SPACE.  
C08 - SOME MOISTURE DAMAGED FLOOR FRAMING AND BOARDS MAY NEED REPLACEMENT PRIOR TO REOCCUPATION.  
C09 - SOME SAG IN ROOF BEAM HERE. NEEDS REPAIR OR REINFORCEMENTS PRIOR TO REOCCUPATION OF THE SPACE.

- D07 - WOOD "CHASES" THAT CURRENTLY HOUSE SOME CELL TOWER EQUIPMENT. CHASES MAY NEED TO REMAIN IN FUTURE LAYOUTS.
