# Faribault Woolen Mill Dam

*Feasibility Study*

Prepared by  
Barr Engineering Co.

May 2026

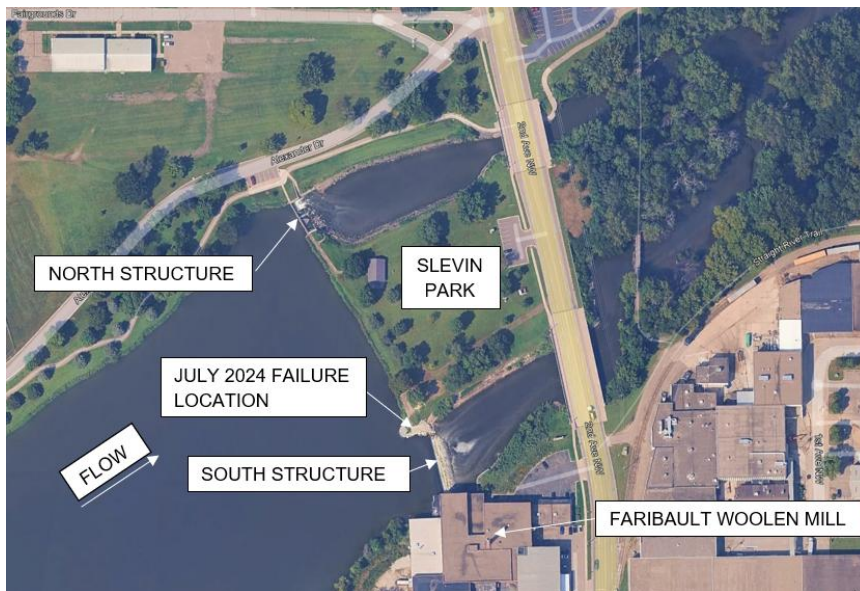
Figure 1-1 Site Layout

Flooding in July of 2024 led to overtopping of the left (north) abutment of the south spillway that caused severe erosion and failure of the north abutment wing wall. The City placed rock and soil at the left abutment to maintain the pool. During this event, water also overtopped the earthen portion of the right abutment of the north spillway for approximately 100 feet. The overtopping of this earthen section has occurred several times as depicted in photos, discussions with City staff, and indicated by historic repair drawings showing re-grading of the area.

The South spillway structure is considered to be in “Unsatisfactory” condition. The South spillway structure’s left abutment has previously failed, and excessive seepage is moving through the abutment without any features to control or mitigate the seepage, such as a filter system.

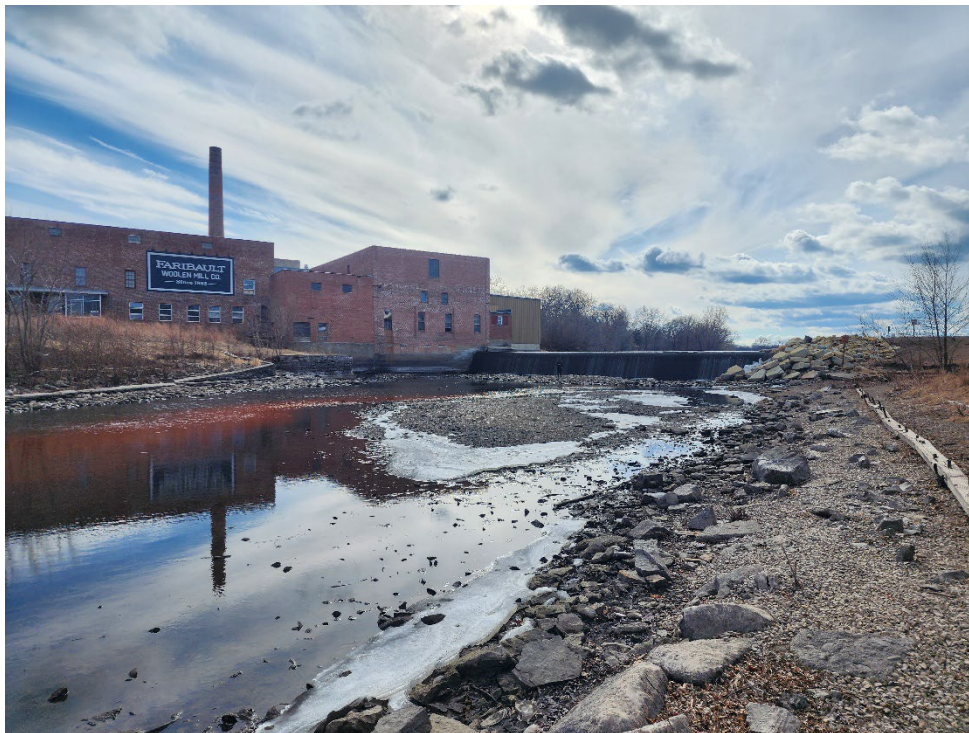
**Photograph 1** Overall view looking Upstream at the South Dam

Overall views of the South Dam are shown in Photograph 1, Photograph 2, and Photograph 3.

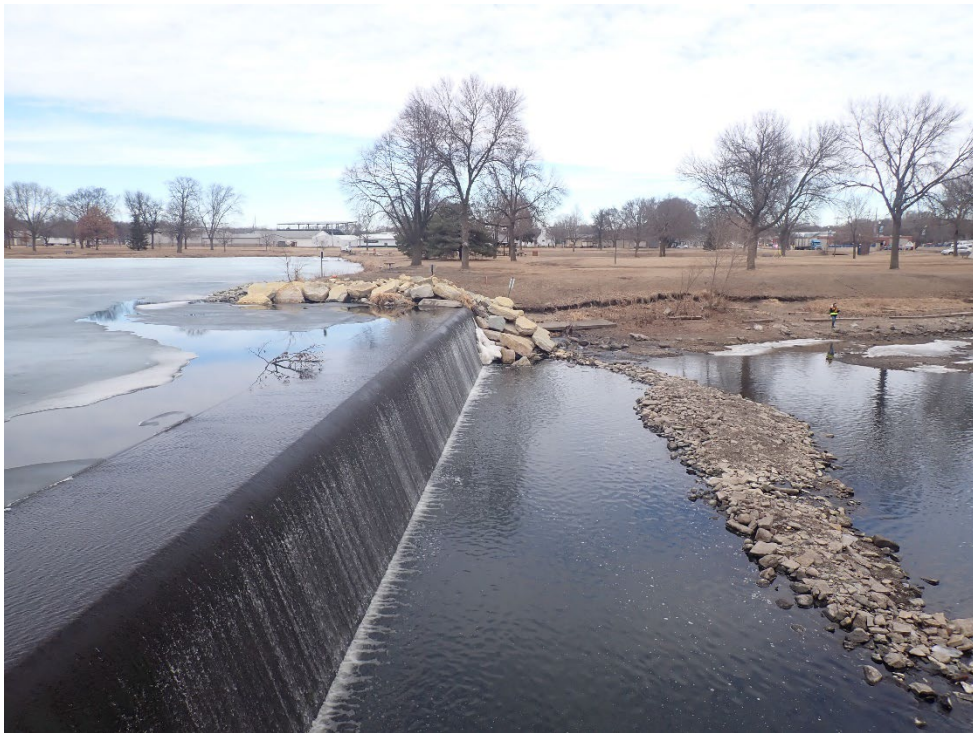
**Photograph 3 Overall view of the South Dam looking left**

Observation of the concrete ogee spillway was limited by the water and ice flowing over the structure, but the reinforced concrete overlay from 1967 appeared to be in satisfactory condition. A scour hole does exist immediately downstream of the spillway. The scour hole depths exceeded 4-feet, but rock was present in the areas accessible by probing. A rock peninsula exists across 80-percent of the channel immediately downstream of the scour hole, likely indicating some movement of rock downstream (Photograph 3).

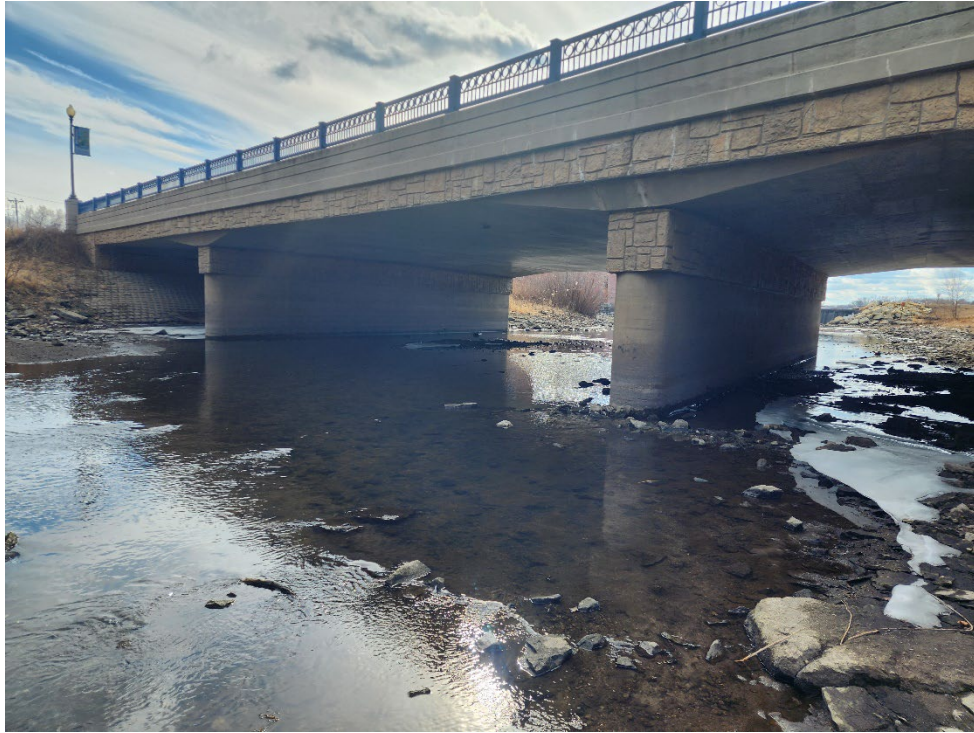
**Photograph 5** 2nd Ave Bridge looking Upstream at the South Dam

- Downstream channel appears in fair condition. The channel is protected with riprap a few feet above the normal tailwater elevation on both sides. Erosion was observed on the left embankment (Photograph 4) and appeared to line up with historic high-water lines on the mill building wall along the right abutment.
- 2nd Avenue bridge limits flow downstream (Photograph 5).
- Pedestrian timber bridges limit flow downstream and also appear to accumulate debris further limiting flow capacity (Photograph 6).

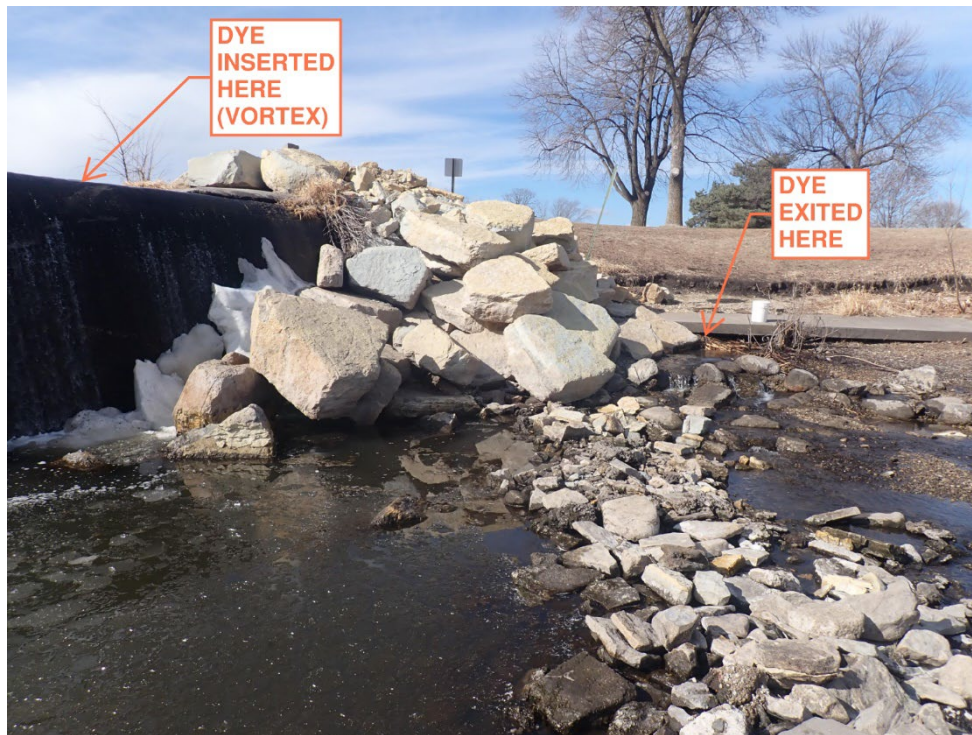
**Photograph 9 Left Abutment Dye Test Setup**

The failed left abutment wall and subsequent rock repair was observed (Photograph 7). Rock was placed both upstream, downstream, and over the left abutment. The concrete wall from the left abutment is visible within the rock. The top of the wall is tilted so as the upstream end is lower than the downstream end, likely indicating a loss of foundation material. At the downstream end of the repair at the elevated concrete walkway, seepage is flowing at a rate greater than 5 gallons per minute from beneath the walkway. A vortex was observed upstream of the left abutment (Photograph 8). Barr completed a dye test by pouring non-toxic, biodegradable liquid dye into the upstream vortex, observing where the dye exited downstream, and timing how long it took to travel downstream. The dye test was performed two times, first with red dye and then with blue dye, and showed that it takes the water just over one minute to move through the left abutment to where it exits beneath the concrete walkway, indicating a clear connection upstream to downstream (Photograph 9, Photograph 10, and Photograph 11).

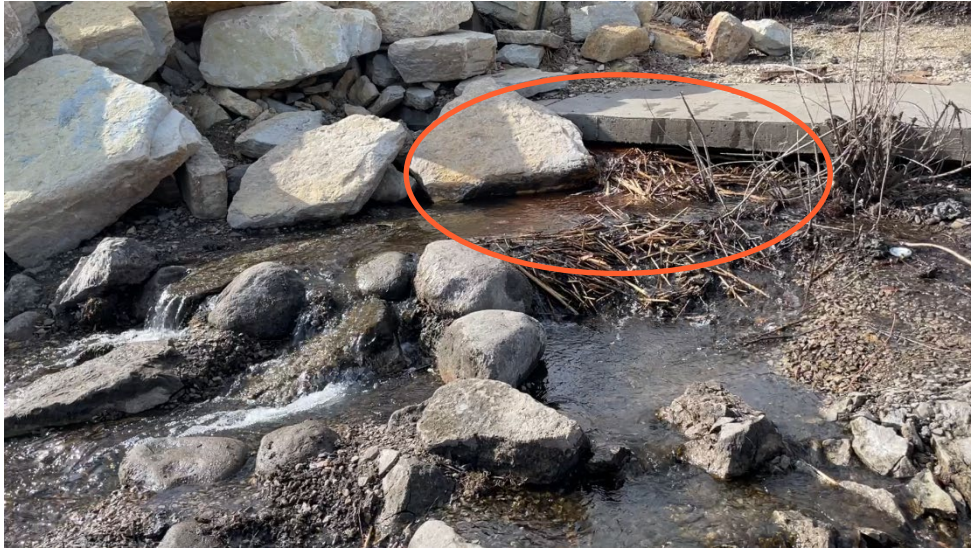
**Photograph 10 Red Dye First Starting to Exit Downstream of the Left Abutment**

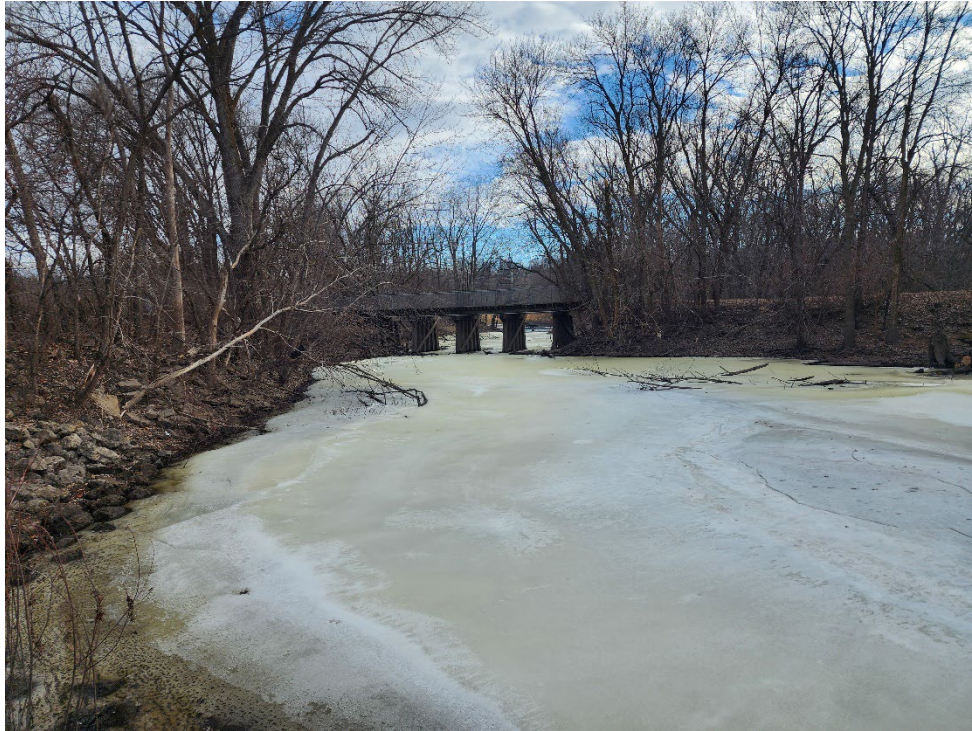
**Photograph 17 Timber Bridge Downstream from the 2nd Ave Bridge and the North Dam**

- Downstream channel (earthen slopes) appears in satisfactory condition. The channel is protected with riprap on both sides from the dam to the bridge. Riprap is present at the water line and varies in height. Minor erosion was noted immediately downstream of the walkway about 3-feet above the tailwater.
- A 4" diameter pipe was found on the left slope about 20-feet downstream of the dam and 3-feet above the tailwater. The pipe was partially crushed and filled with mud.
- 2nd Avenue bridge limits flow downstream (Photograph 16).
- Pedestrian timber bridges limit flow downstream and collect debris further limiting flows (Photograph 17).

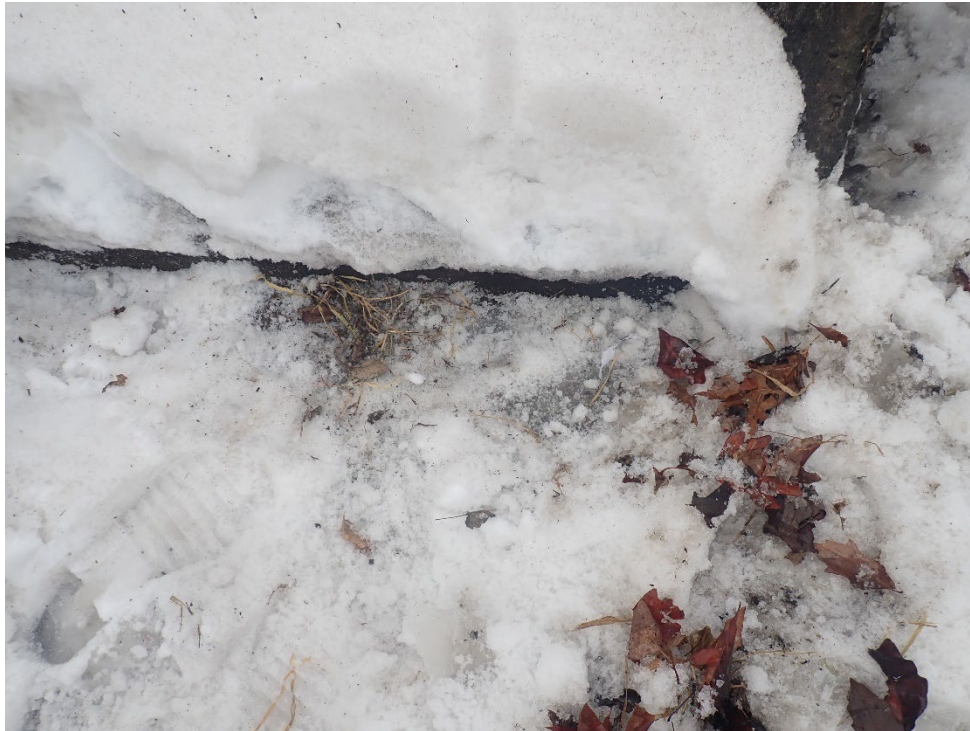
The majority of the joints between the downstream edge of the concrete dams and the base slab appeared to be in satisfactory condition (Photograph 19). There were a couple of exceptions. In one location vegetation growth was observed in this joint, likely indicating separation between the dam and the slab underneath it (Photograph 20). At the ogee overflow section, the joint is tight for about half the distance on the southern side; however, a small gap exists where the ogee ties to the concrete slab on the north half of the spillway. A probe was able to be inserted 3-feet before it hit a solid obstruction (Photograph 21). No visible water was flowing from this gap. A void was also identified beneath the left wingwall (Photograph 22).

**Photograph 20** Vegetation Growth in Joint Between the Downstream Edge of Concrete Dam and the Base Slab

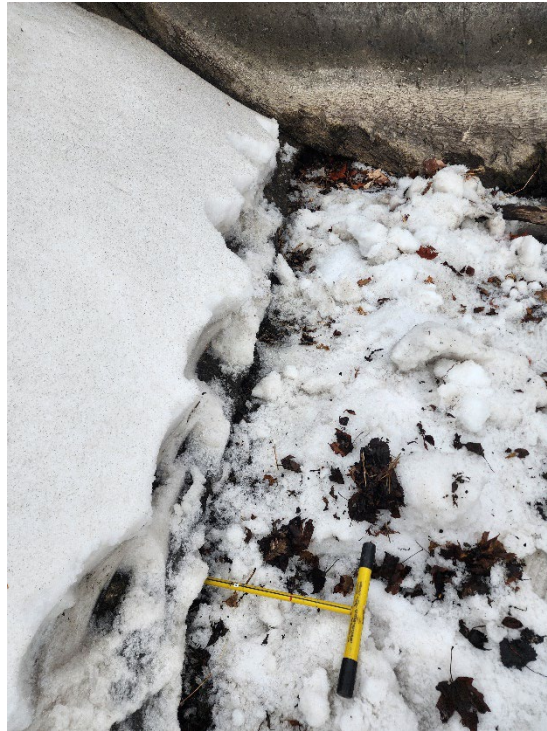
**Photograph 21 Undermining in Joint Between the Downstream Edge of Concrete Overflow Section and The Base Slab**
